WEEKLY LIST OF ACTIONS TAKEN ON PROPERTIES: 7/05/93 THROUGH 7/09/93

Boyd, Theron, Homestead Hartford, Windsor County, Vermont

National Register of Historic Places Registration Form

Boyd, Theron, Homestead Hartford, Windsor Co., Vermont

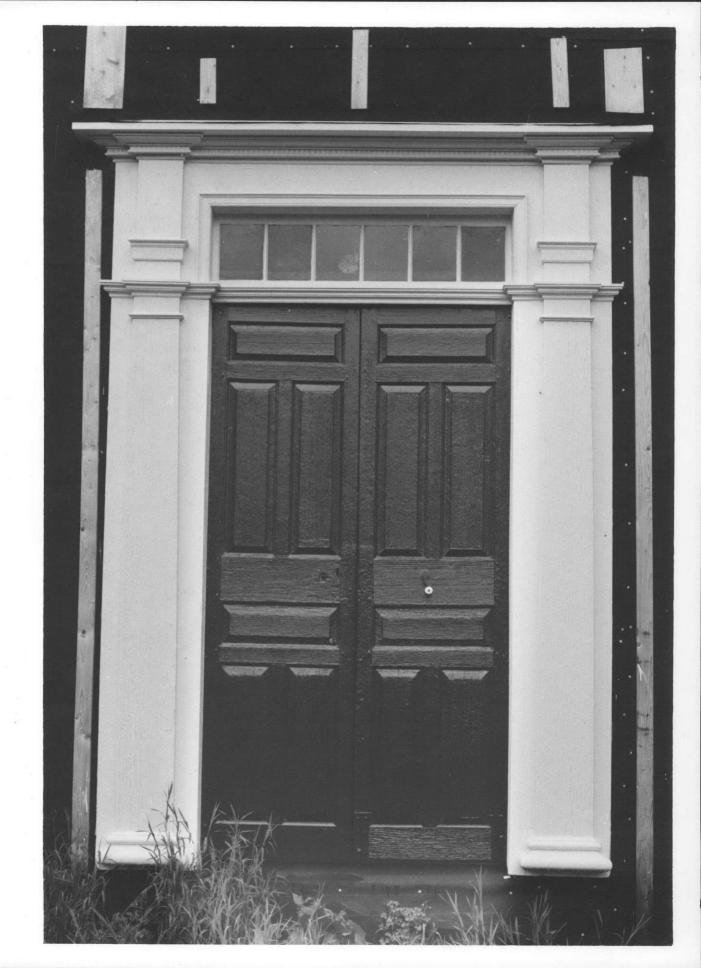
Boyd, Theron, Homestead Hartford, Windsor Co., Vermont Credit: John P. Dumville Date: November 1992 Negative on file at VT Division for Historic Preservation View looking north; frontispiece of main block of house (#1)

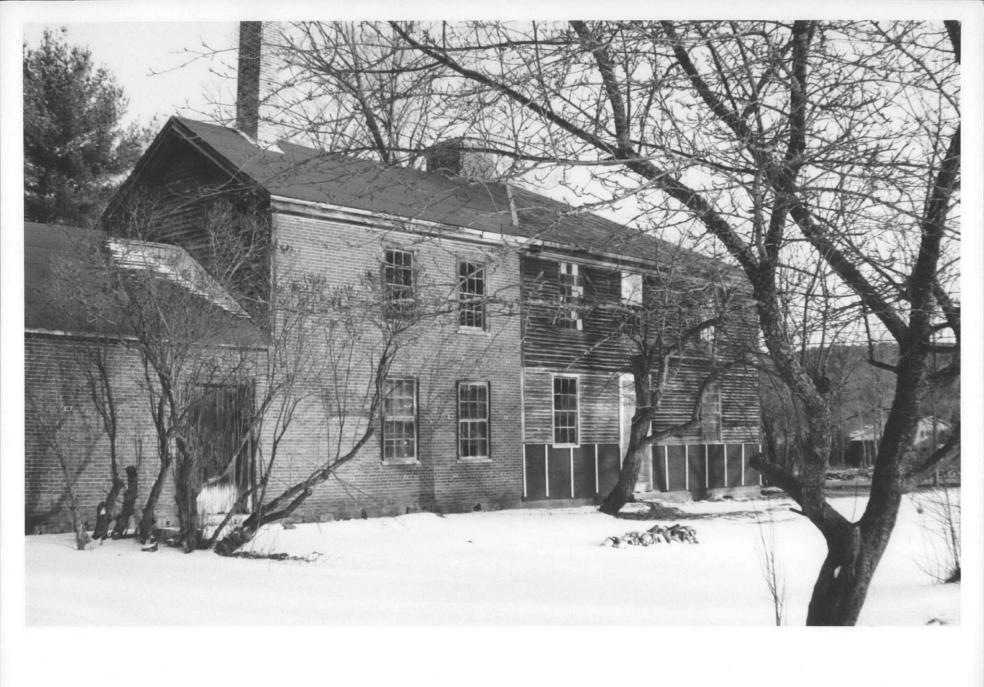
Photo 3

> Boyd, Theron, Homestead Hartford, Windsor Co., Vermont Credit: Betsy Baten Date: March 1992 Negative on file at VT Division for Historic Preservation View looking southeast, west side of house (#1)

The side walls are not as symmetrically arranged as the front wall, as windows were placed to accommodate the uses of the rooms within. The west wall is divided into three bays (window, door, window) with the pantry window offset below the northwest chamber window. The pantry sash, replaced in 1936, is 6/6 with Greek Revival period muntins. The door at the ground level is a single-leaf, raised panel door with a beaded, trabeated surround, and a five pane glass transom.

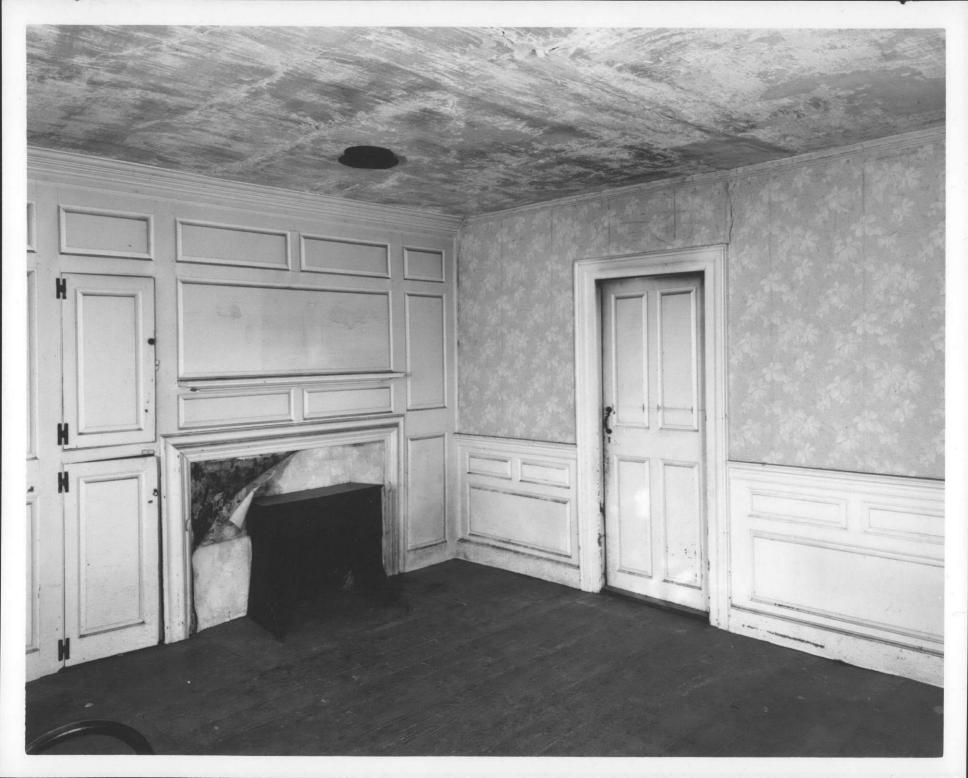
Photo 7

Boyd, Theron, Homestead Hartford, Windsor Co., Vermont Credit: David Bohl Date: Sept./Oct. 1987 Negative on file at VT Division for Historic Preservation View looking northwest, front east parlor of house (#1)

The east front parlor is entered from the entry hall and also from the kitchen. Most features are from the 1786 period of construction. Fir flooring is fastened with wrought nails. Walls are plastered except for wainscoting and a raised panel fireplace wall on the west side of the room, which are beautiful examples of late 18th century woodwork. The NPS Form 10-900-a

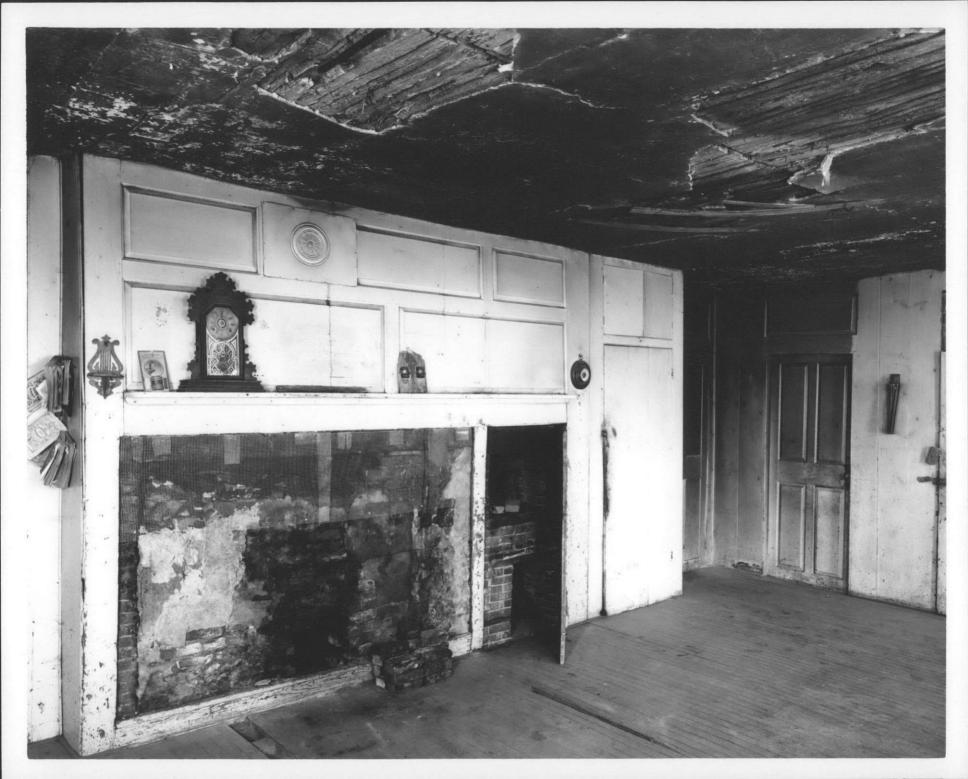
Boyd, Theron, Homestead Hartford, Windsor Co., Vermont Credit: David Bohl Date: Sept./Oct. 1987 Negative on file at VT Division for Historic Preservation View looking southwest; fireplace wall of kitchen in main block of house (#1) -C-18

The kitchen, located in the north (rear) central portion of the first floor, is extraordinary for its state of preserva-A lone cast iron sink in this room is the only modern tion. convenience in a house never otherwise altered for electricity or plumbing. The focus of this room, a prominent cooking fireplace with a bake oven with a removable tin door, has a simple surround, a later applied shelf, and is framed by raised wall paneling. It was closed off in the late 19th century to house a wood stove. A mica schist hearthstone is set out at the level of a 19th century fir subfloor, which is nailed with perfected-head nails. A space between the hearthstone and the hearth has been filled with sand into which stringers have been set to support and provide attachment for a 20th century tongue and groove oak floor toe-fastened in place with wire nails. A cupboard to the right of the hearth was added early in the 19th century, as evidenced by paneling with light Federal period beading that contrasts with the 1786 paneling with a heavier Georgian era bead that forms the back wall and east side of the cupboard.

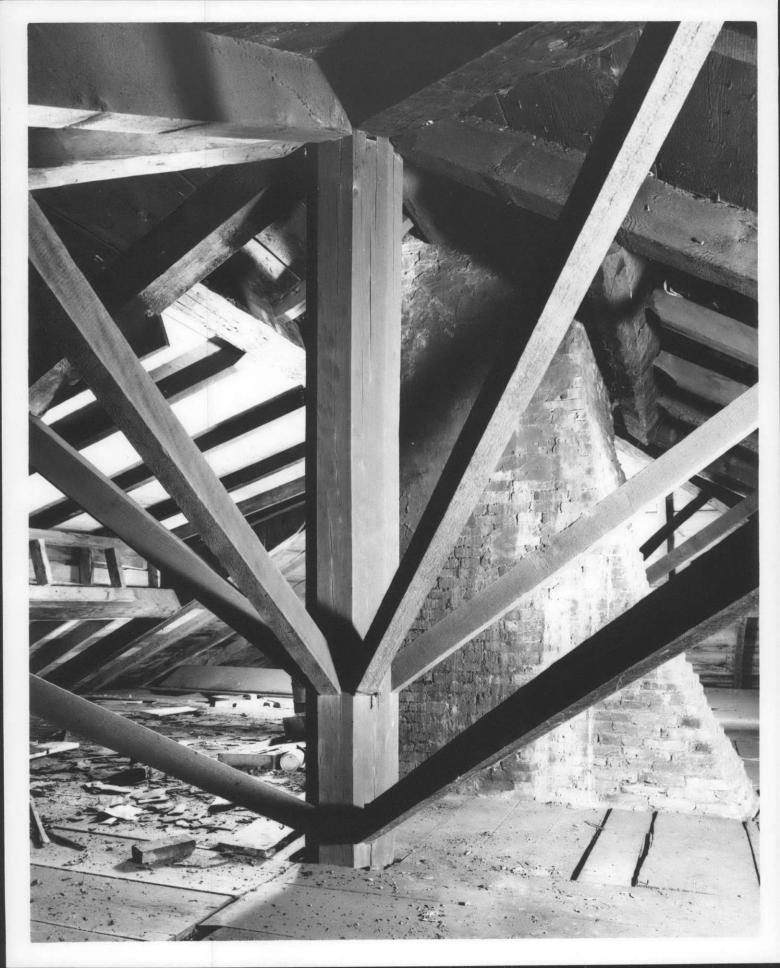
Boyd, Theron, Homestead Hartford, Windsor Co., Vermont Credit: David Bohl Date: Sept./Oct. 1987 Negative on file at VT Division for Historic Preservation View looking east; framing of attic in main block of house (#1)

Flooring on the east side of the attic is fastened with perfected-head cut nails and boards on the west with wrought nails. Boards on the north side appear to be recycled, possibly from the east chambers as they are well-worn on the face.

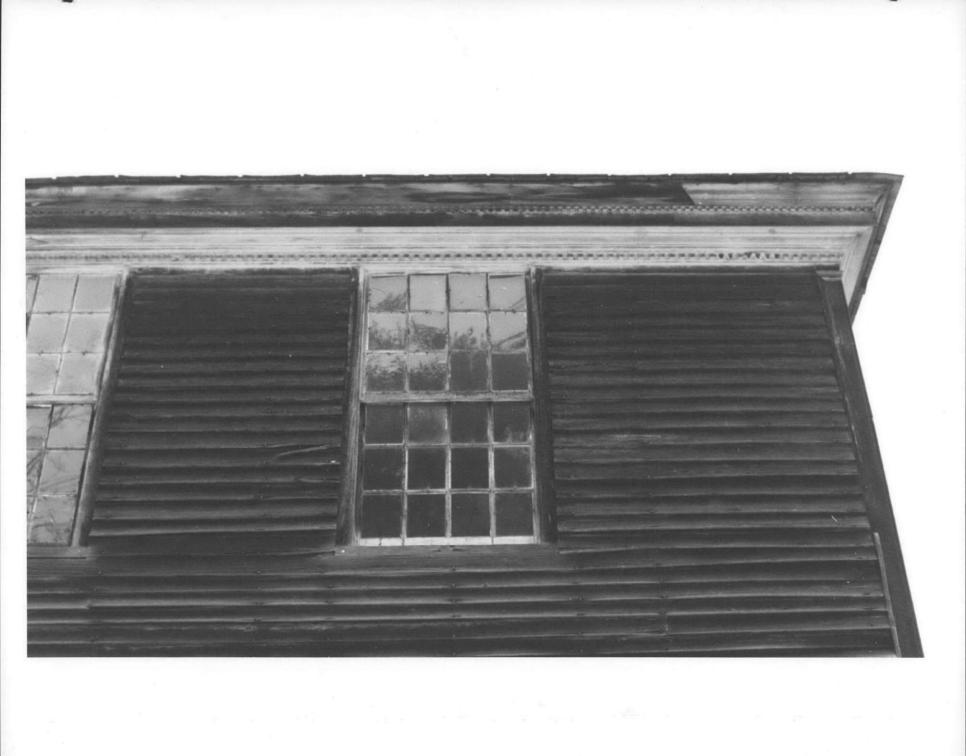
Boyd, Theron, Homestead Hartford, Windsor Co., Vermont Credit: John P. Dumville Date: November 1986 Negative on file at VT Division for Historic Preservation View looking north; cornice and window of upper southeast corner, front wall, house (#1) Photo 5

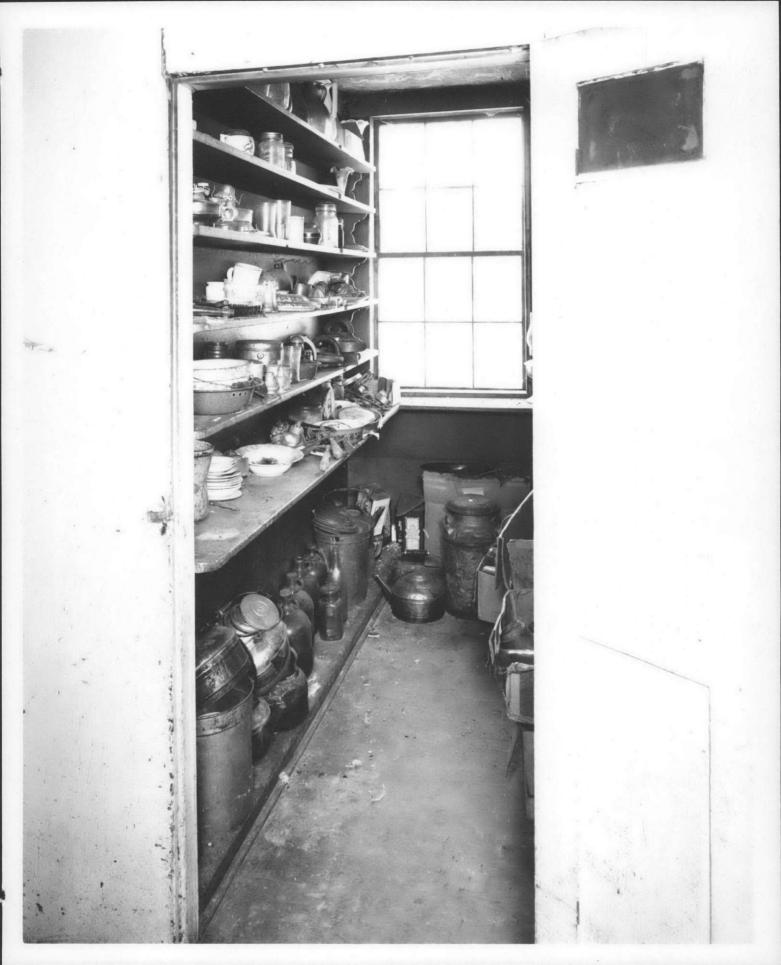
Boyd, Theron, Homestead Hartford, Windsor Co., Vermont Credit: David Bohl Date: Sept./Oct. 1987 Negative on file at VT Division for Historic Preservation View looking west; pantry off kitchen in main block of house (#1) Photo 9

A pantry and secondary stairhall are located off the kitchen to the west. One early intact layer of paint in the pantry gives evidence that this room has never been altered or renovated. Shelf cleats, horizontal wallboards, and cupboards held in place by wrought nails also indicate that the pantry is in original condition. The pantry has open shelves runningalong the south wall and on the north wall cupboards below the counter and open shelves above. The ends of the shelves on the south wall toward the window are intricately scalloped. The second floor stairway however had originally opened off the kitchen and was reversed to open off a side wall in the early 19th century. This side wall has vertical board paneling with one layer of stain.

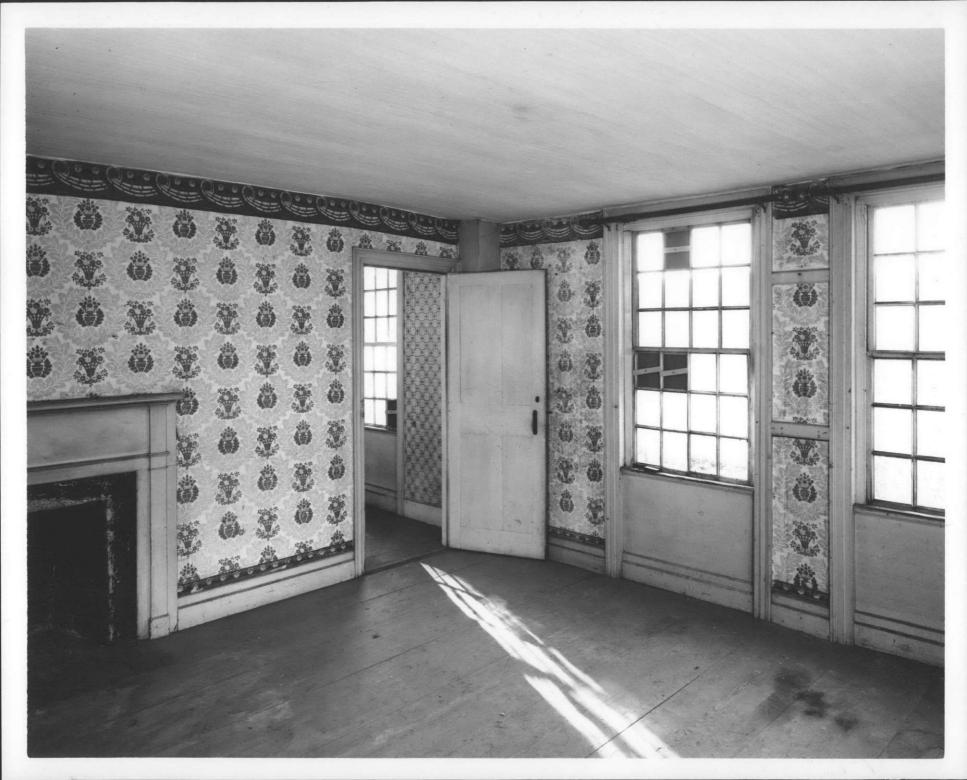
Boyd, Theron, Homestead Hartford, Windsor Co., Vermont Credit: David Bohl Date: Sept./Oct. 1987 Negative on file at VT Division for Historic Preservation View looking southeast; west front second floor bedroom in main block of house (#1) Photo 10

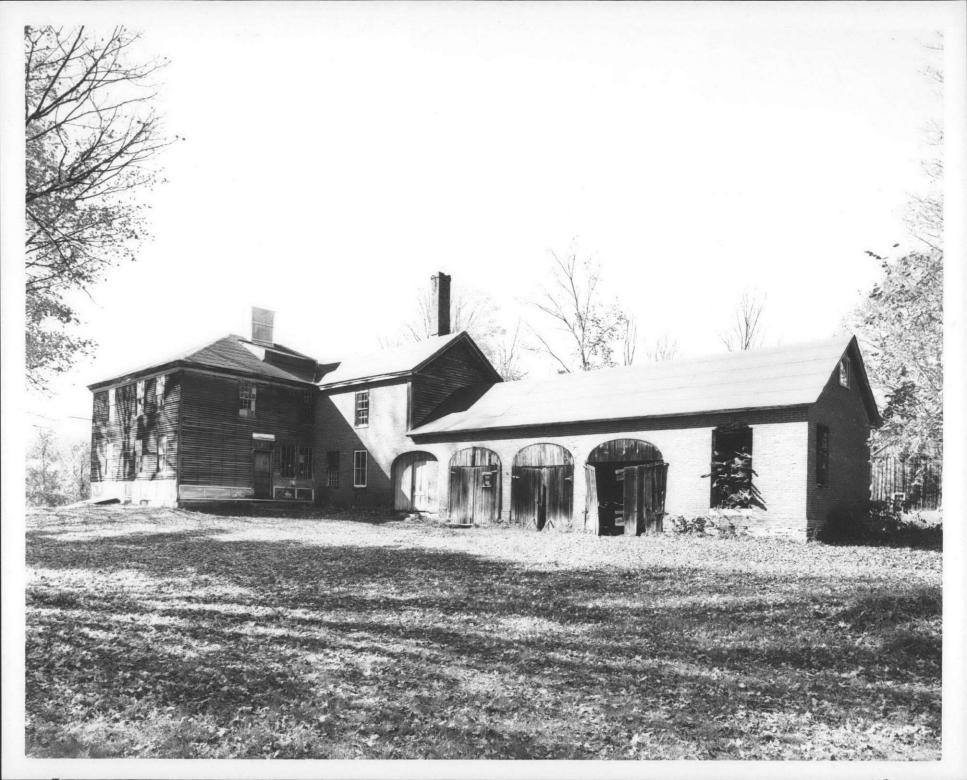
Boyd, Theron, Homestead Hartford, Windsor Co., Vermont Credit: David Bohl Date: Sept./Oct. 1987 Negative on file at VT Division for Historic Preservation View looking southwest, side and rear of main block, and front wall of ell of house (#1) Photo 2

The ell, two bays wide and measuring 70' x 20', appears to have been added to the house perhaps in the early 1800s. It was originally two stories, but a fire caused by lightning The cornice of destroyed most of the second story in 1936. the ell and main block are at the same height. The second floor of the ell terminates abruptly at the mid point of the first carriage bay as a result of the fire. The ell is built of warm red brick laid in a nine course American bond with thin tooled joints that required minor repointing in 1991. The four lowest courses protrude to form a raised water table over a random rubble and fieldstone foundation on the north and west walls, while on the east wall the fieldstone foundation is flush with the wall. On the north and west walls, staging bricks are set in tenth course headers at four foot intervals. Both sections of the ell have a gable roof covered with asphalt paper. A tall brick kitchen fireplace chimney built on the north wall of the summer kitchen was repaired in 1991.

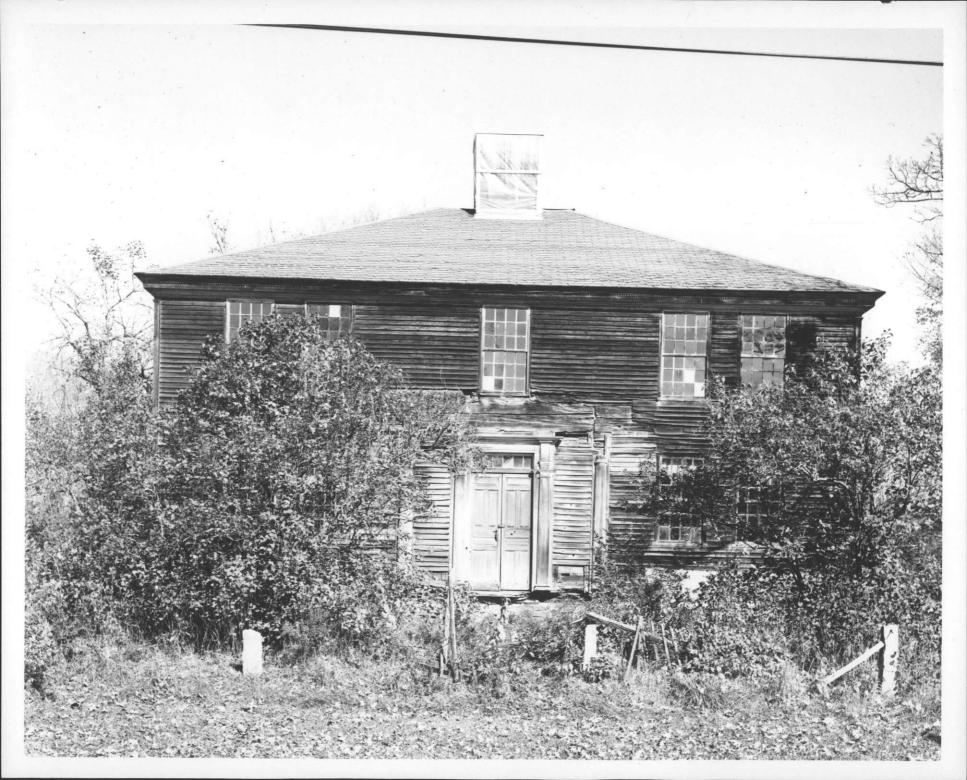
87-C-1

Boyd, Theron, Homestead Hartford, Windsor Co., Vermont Credit: David Bohl Date: Sept./Oct. 1987 Negative on file at VT Division for Historic Preservation View looking north, front facade of main block of house (#1)

The symmetrical front (south) facade is divided into five bays, with the first and second and fourth and fifth bay windows being closely spaced together. The central element of this facade is an elaborate, raised-paneled, double-leaf entry door with a six pane glass transom and a Doric pilastered surround. In 1992 the door and surround were repaired and conserved, preserving the vast majority of the original materials. Sometime around the turn of this century a Colonial Revival entry porch was added to shelter the front door, and the clapboards flanking the door were changed. It was remodelled at least twice, and no longer exists.
