RE: Sheldon Museum, Middlebury, VT

Re: Request for Variance under Section 1-4.4 (NFPA 101-1988)
and Section 513.1 Special Historic Buildings and Districts (BOCA NBC-1987)

Reference: Sheldon Museum Addition, Middlebury, VT

SHELDON MUSEUM MIDDLEBURY, VERMONT
CENTRAL BUILDING PROJECT
VT-AD-489

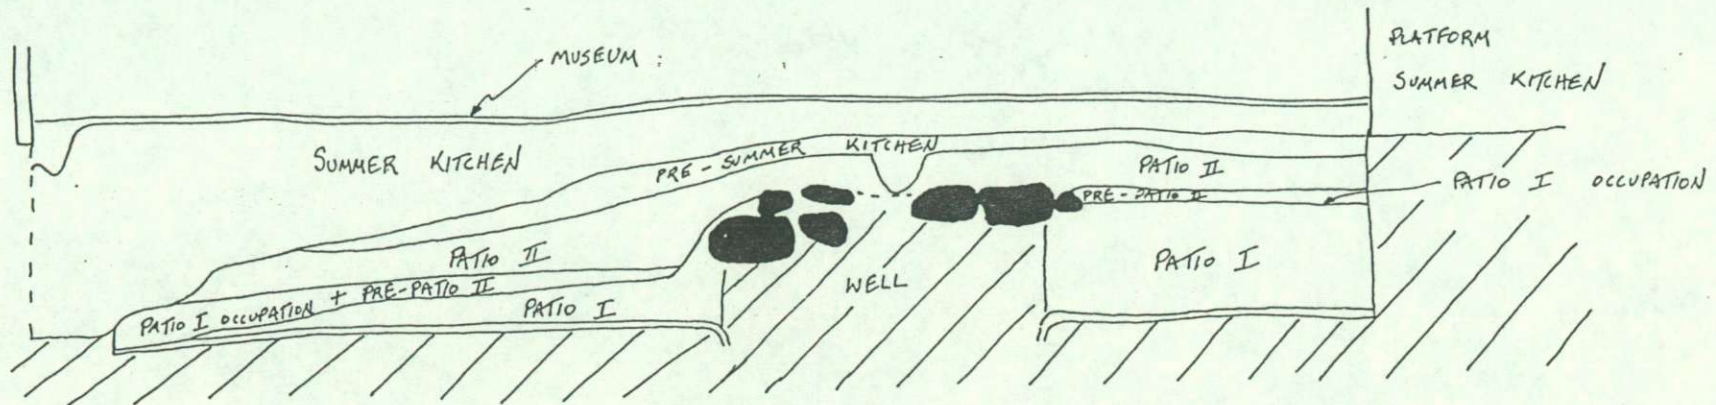
FIGURE 23

EVOLUTION OF THE "SUMMER KITCHEN"

Basically figure portrays the evolution of the "summer kitchen". As clearly demonstrated by Sally McMurry the kitchen was not only the "business room" of the house but, behavior associated with the rear entrance was explicitly different from those related to other entrancways. (McMurry 1988). Clearly from the initial occupation of the 1829 house, the kitchen design was inadequate to contain the ~~activities~~ functions demanded of it. Subsequently, activities spilled outward from the door. In addition, wood and water procurement demanded use of the back door area, and the artifact assemblages suggest that other kitchen (butchering) ^{cleaning} and social activities (smoking) occurred here as well. Over time several architectural facilities were constructed in order to provide more permanent work/social space (especially periods IV and VI). It appears that similar activities were occurring around the kitchen/ back door from ca. 1830 up until the conversion of the home into a museum (ca. 1930?). The deposition of cultural materials reflecting these activities depended in part on the occupants conception of this space (I.e.: is the area a dump or is it to be kept clean) ^{and their access to it.} It is interesting to note that the two main artifact bearing layers # 8 and #6 are both followed by periods which expand the architectural features (Period IV and VI).

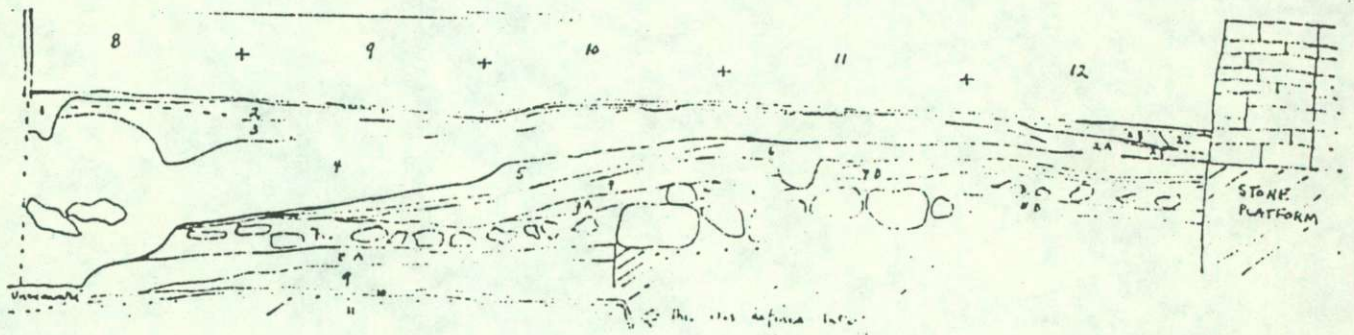
ACTUAL PROFILE

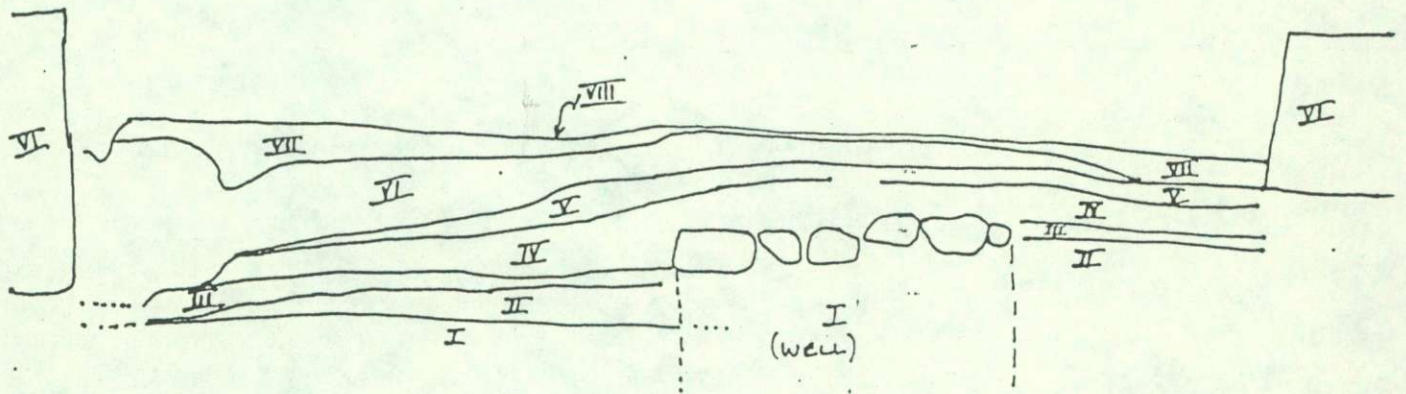
SCHEMATIC PROFILE
