Certified Local Government
National Register Final Review Report

Name of Property Jericho Rural Historic District
Address Intersection of Jericho Road & Jericho St. and surrounding properties.
Owner Multiple property owners - 23 in Hartford & 4 in Norwich

Jericho Rural Historic District
Hartford and Norwich, Windsor Co., VT

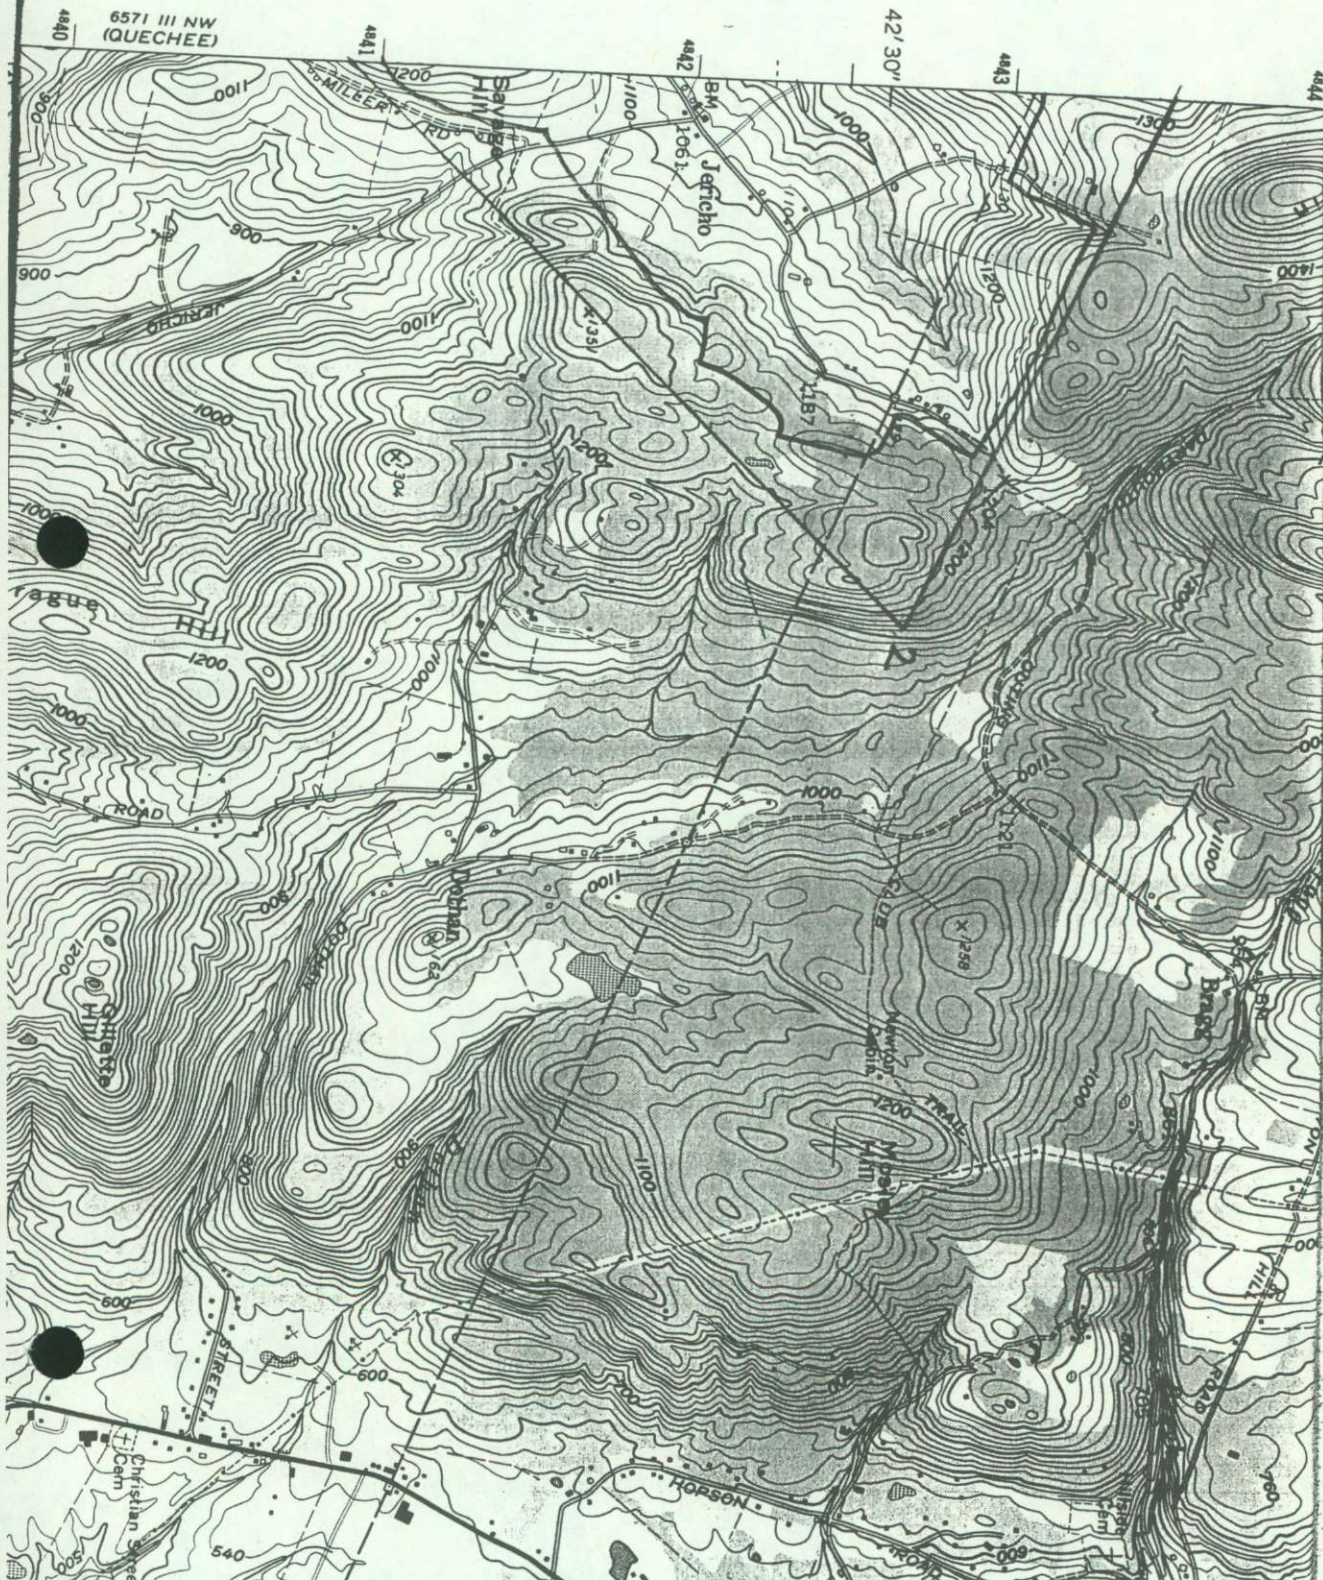
JERICHO RURAL
HISTORIC DISTRICT
HARTFORD & NORWICH
WINDSOR CO.
VERMONT

- CONTRIBUTING BUILDING
- NON-CONTRIBUTING BUILDING
- HISTORIC DISTRICT BOUNDARY
- == ROAD
- ~ JERICHO BROOK
- www EDGE OF WOODS
- ooooo STONE FENCE
- - - TOWN BOUNDARY
- ⊕ OLD SUGARBUSH
- + APPLE TREES

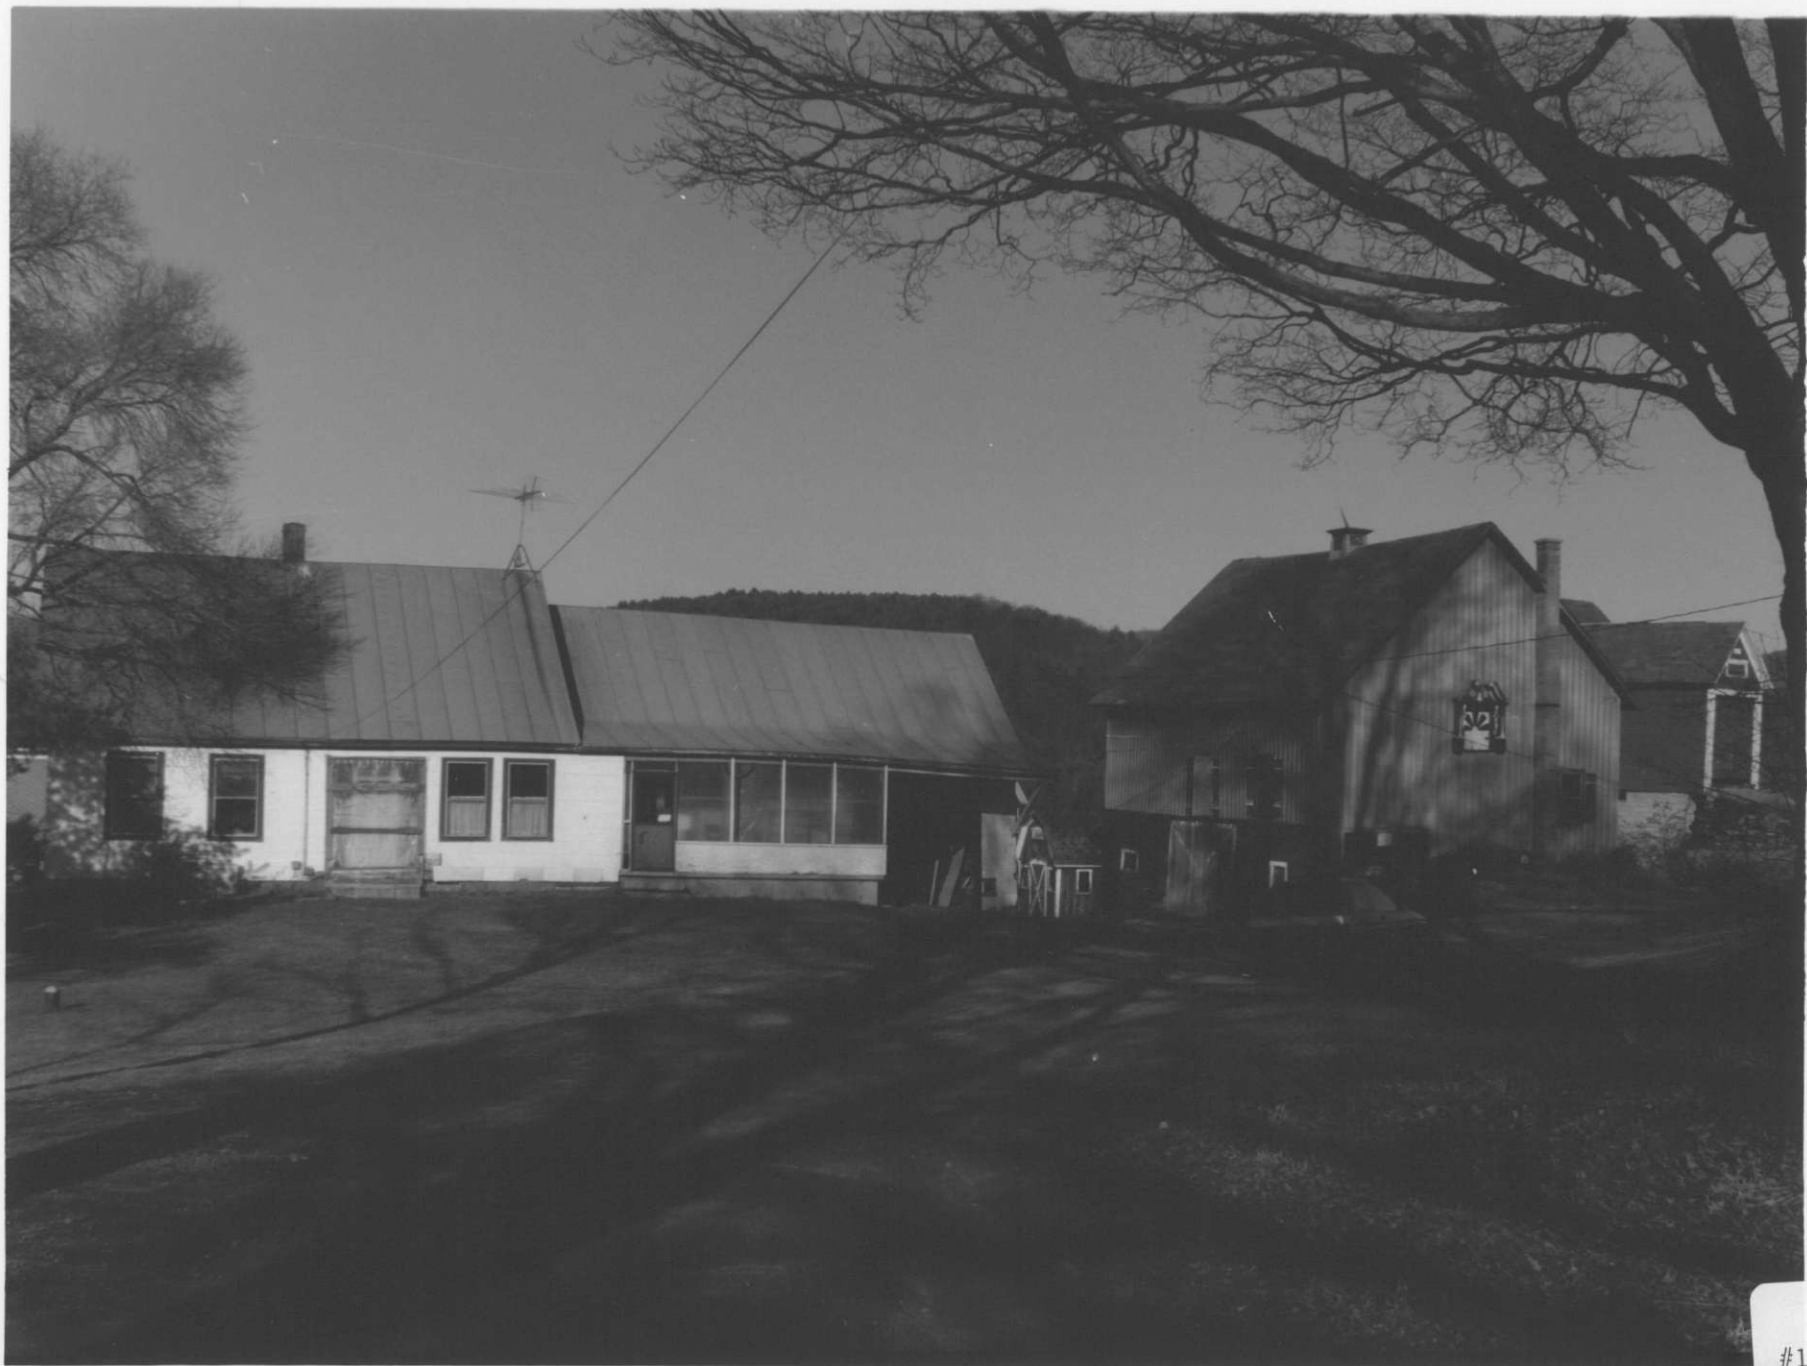
Thaddeus and Emily Dutton Farmstead
Property #1, Jericho Rural Historic District
Hartford, Windsor County, Vermont
Photo by Paula Sagerman
Facing north toward farmhouse and horse barn
Negative filed at VT Division for Historic Preservation
Photograph #1

This asymmetrical Classic Cottage faces the road (south) and is a 1-1/2 story wood frame structure with a cut-stone foundation, asphalt-shingle siding, and a standing-seam metal side-gabled roof. The roof has a slight overhang with a narrow, molded cornice and short cornice returns. Any

other surviving trim is concealed by the siding. A small brick chimney rises from the ridge. The off-center front door is boarded up and the left bay of the southwest gable wall has a double-leaf wood door with tall narrow lights and small lower panels. The front door is flanked by a pair of windows on each side. Except for three six-over-six wood windows in the west gable wall and one diagonal six-over-six window in the east gable, all of the windows are one-over-one replacement windows with aluminum storms. A large wing extends from the east gable wall of the house and has a contiguous rear wall with the main section. The wing has a concrete foundation, asphalt-shingle siding, and a standing-seam metal side-gable roof. The front wall of the wing has a garage door opening at its right end and a porch at its left end; both the doorway and porch are covered by a continuous standing-seam metal shed roof. The porch has a concrete foundation and thin wood posts over a half-wall.

The asymmetry of the main section of the house may indicate that it was constructed in two stages. The date of the wing is unknown, but a break in the rear cornice indicates a later date than the house. This house probably had originally had Classic Cottage features such as a decorative entranceway with pilasters and an entablature, and bold corner posts, but because of the alterations its original appearance is unknown. The massing, roof cornice and window and door openings appear to be original. The asphalt-shingle siding and concrete foundation appear to date to the mid twentieth-century. The one-over-one windows, the porch, and the garage opening appear to date to the late twentieth-century and may have replaced an earlier full-facade porch. The roof is in very good condition but the siding and the exposed woodwork are very deteriorated.

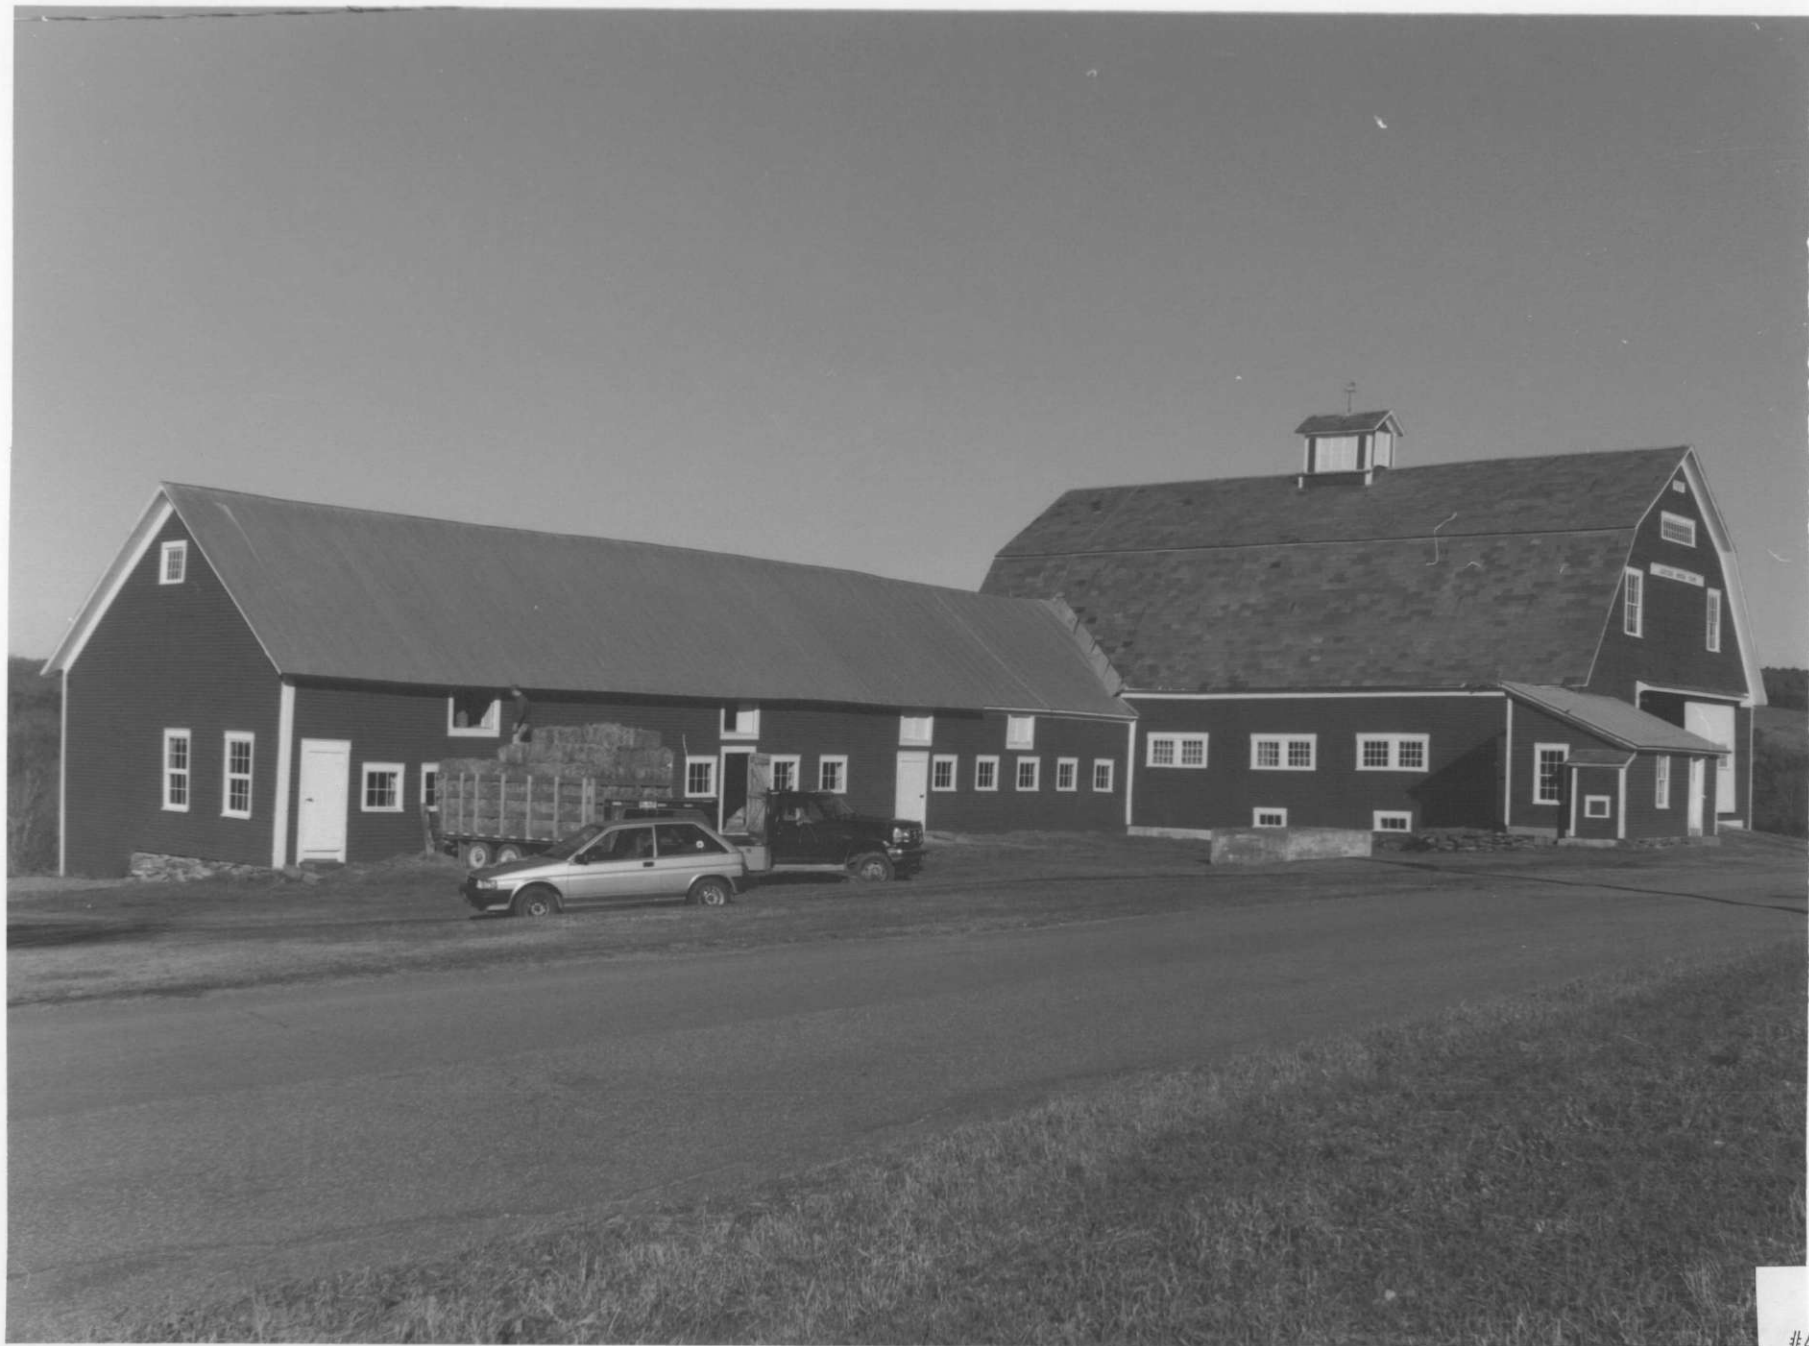
Pixley/Sprague Farmstead
Property #4, Jericho Rural Historic District
Hartford, Windsor County, Vermont
Photo by Paula Sagerman
Facing northeast toward Dairy Barn (B and C)
Negative filed at VT Division for Historic Preservation
Photograph #7

This high-drive dairy barn is reported to have been constructed in 1903 by the Dulacs of Lebanon, New Hampshire. The ground level was probably originally a manure basement and converted to a ground stable barn. The shed additions appear to date to the mid twentieth-century; the one attached to the northwest elevation may have served as a milk room. This barn is in good condition.

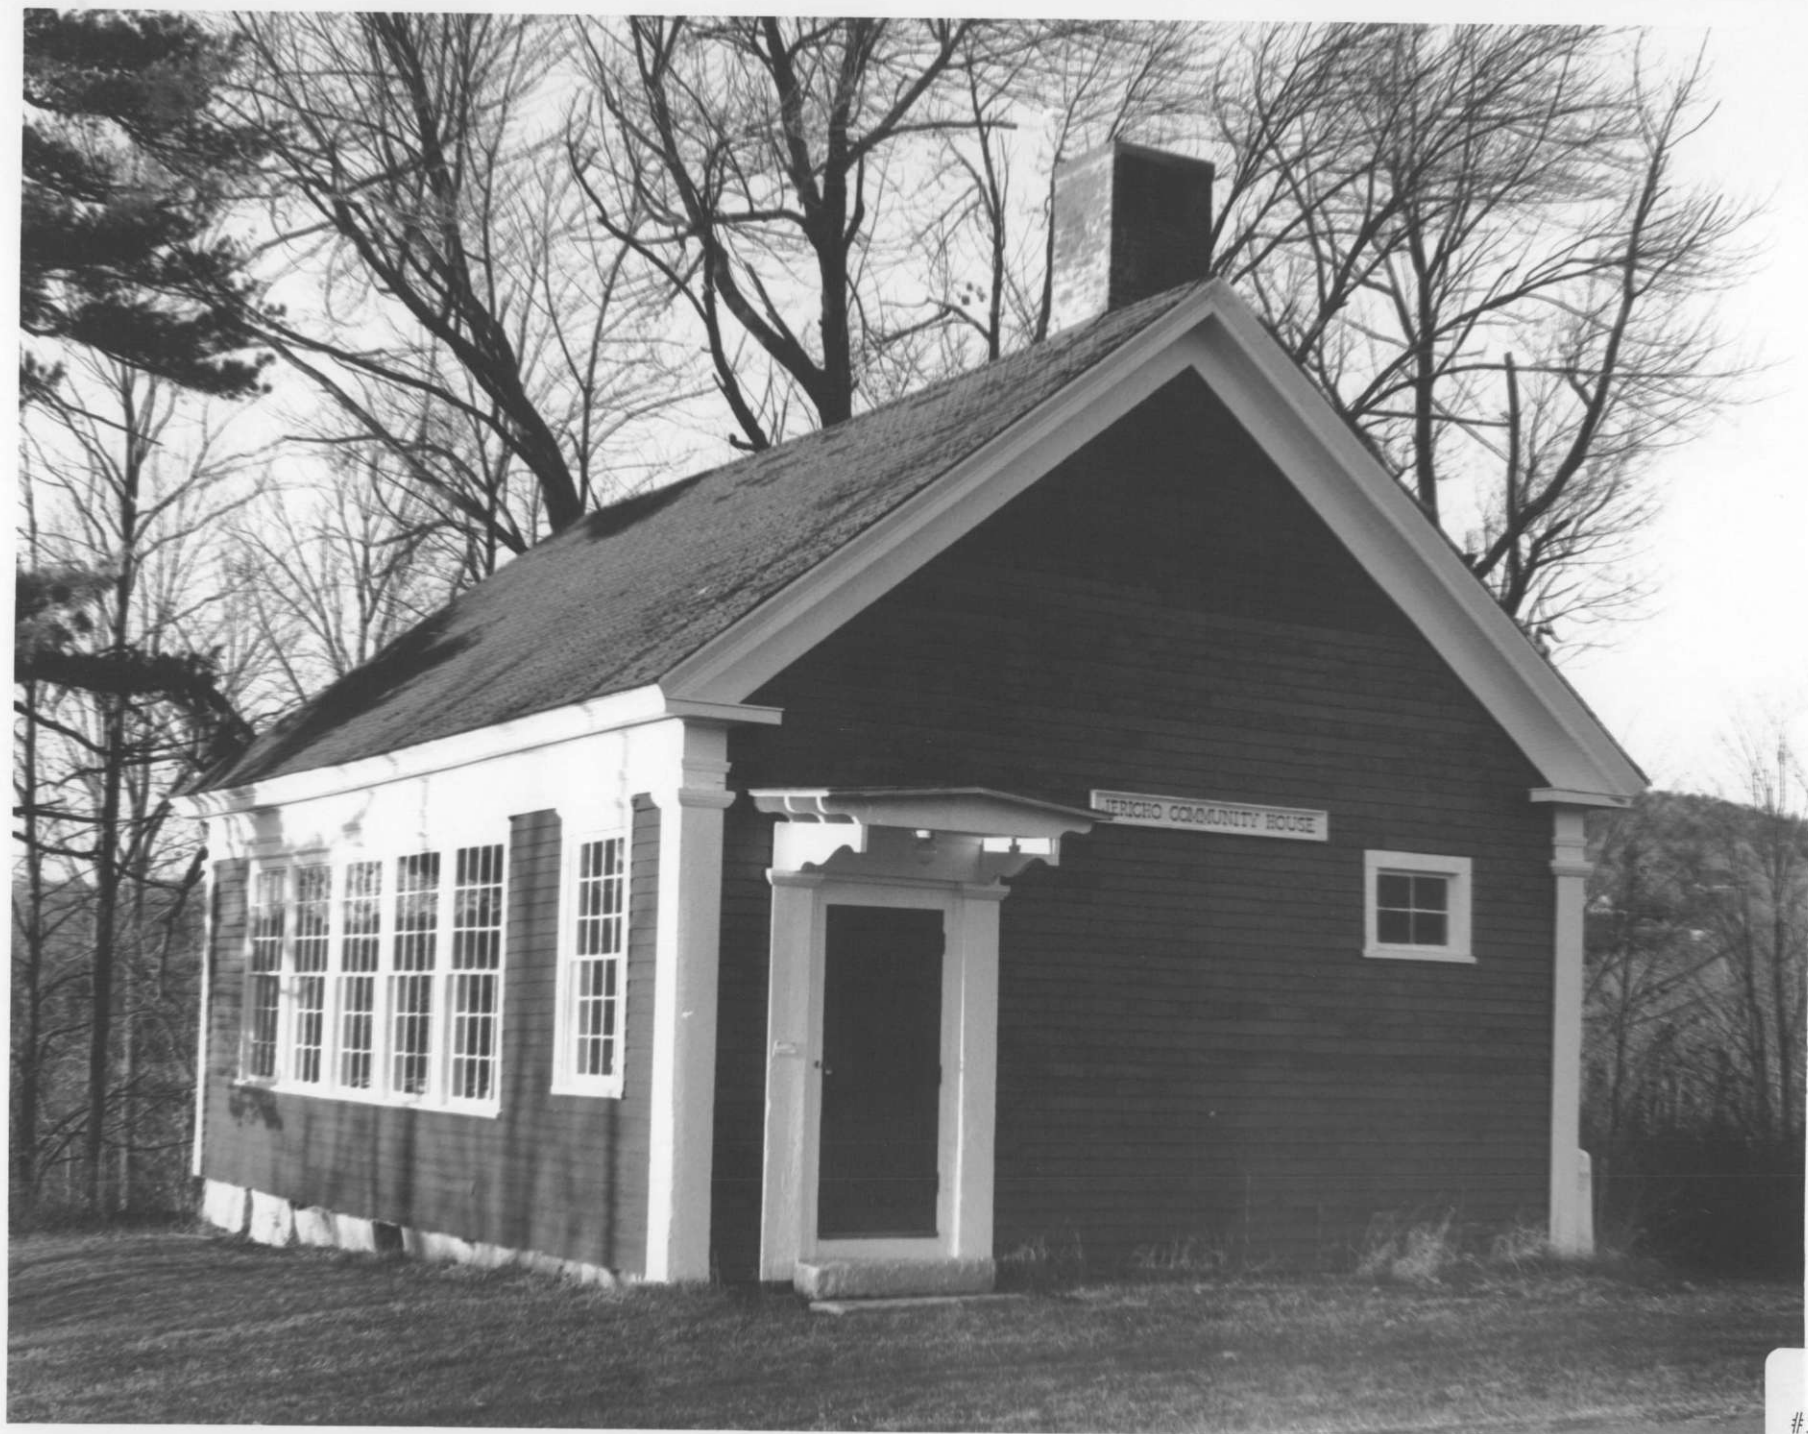
District #7 Schoolhouse
Property #5, Jericho Rural Historic District
Hartford, Windsor County, Vermont
Photo by Paula Sagerman
Facing north
Negative filed at VT Division for Historic Preservation
Photograph #8

This former one-room schoolhouse is located on the north side of Jericho Street about one hundred yards west of the intersection of Jericho Road. It faces south and sits back slightly from the road on a small, open lot that backs up to a small stand of mixed trees. Just to the east of the school are the agricultural buildings of property #7. The schoolhouse was constructed in 1849 on a 1/3 acre lot in the southeast corner of Philo Sprague's (#4) property. It replaced the first Jericho school, which had fallen into disrepair. (The first school was of brick construction and stood about one hundred yards west of the extant schoolhouse. A slight knoll near the road reveals its location, where a pile of bricks remained exposed until about the mid twentieth-century.) The school remained in continuous use until its closing in 1947, and since 1951 been owned by the Jericho Community Association, which maintains it and uses it for meetings and social functions.

The 1-story Greek Revival-style school has a rectangular footprint oriented perpendicular to the road. It sits on a cut-stone foundation and has wood-frame walls with clapboard siding and a slightly overhanging, front-gable asphalt-shingle roof. A square brick chimney rises from the ridge towards the front of the building. Architectural trim includes bold, capitated corner posts, a tall molded entablature, cornice returns, a molded gable rake, entranceway pilasters, and except for at the bank of windows, molded window cornices. The front (south) gable wall has an entrance at the extreme left and a small, high-set four-pane window at the extreme right. The entrance has a low-sloped gabled door hood with exposed scrolled rafter tails supported by two large scrolled brackets. The entrance contains a six-panel "cross-and-prayer-book" door. The west wall contains a bank of five, large, twelve-over-twelve windows and an individual, smaller twelve-over-twelve window to the right. The east wall contains an individual twelve-over-twelve window that mirrors the individual window on the west wall. The rear wall contains three, regularly-spaced, twelve-over-twelve windows. Greek Revival features of the schoolhouse include the gable-front orientation and bold architectural trim.

Except for the window configuration and modern roofing, the schoolhouse appears much as it did when constructed. The original fenestration comprised of four, regularly-spaced, six-over-six windows on each side wall, and no front window. The current bank of windows was installed in the early twentieth-century. The two individual window openings near the front of the building are original. The original roofing material was wood shingles. The current door replaced a paneled

wood door with one upper light sometime in the twentieth century. The building is in very good condition.
