NATIONAL HISTORIC LANDMARK NOMINATION

ROCKINGHAM MEETING HOUSE

The Rockingham Meeting House, begun in 1787 or 1788 and finished in 1799-1801, sits with its related burial ground in a nearly rectangular four acre lot atop a small, steep hill in the village of Rockingham which overlooks the Williams River valley north and west. The Meeting House is an ample two-story, forty-four feet by fifty-six feet by forty-four feet tall. wood-frame New England meeting house typical of the eighteenth century, one of the last built remaining. It is of massive post-and-beam construction, five by three structural bays, with four kingpost trusses uniting the walls and supporting a gable roof covered in cedar shingles. Clapboarded and resting on low, flat foundation stones, it has its double-door formal entry centered on the broad, twenty-four-foot tall eaves-side wall facing south. The symmetrical twelve feet by twelve feet by twenty-four feet tall, gabled stair-towers are centered beneath each gable end, each with entries also centered on south-facing nineteen-foot walls. Styled in a late Georgian mode, it shows its richest embellishment in fluted pilasters and a pediment framing the formal entry,

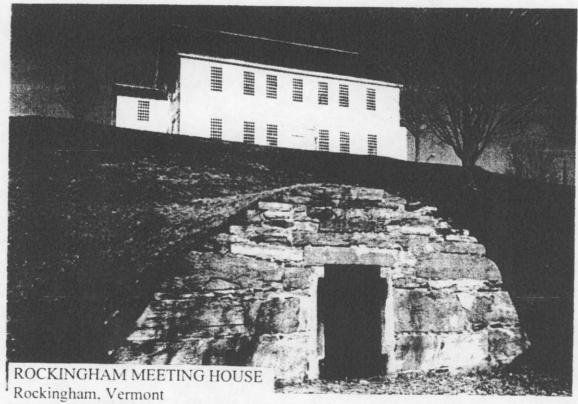
South (front) elevation and burial vault Photo by C.B. Johnson, 10/99

Seen from the south, the Meeting House appears on the hilltop above and slightly east of the storage vault, and scattered mature maples line portions of the drive, particularly at the south cemetery wall. This is the historic viewpoint for appreciating the vernacular site design and primary formal facade (facing south-south-east), which is fifty-six feet in length, plus the two, smaller, set-back twelve foot stair towers at each end. The focus of the facade is the formal entry, consisting of an eight-panel, double door on a step recessed within a simple architrave. Surrounding this are fluted pilasters applied on wide fascia boards that support a heavily-molded entablature with bulbous cushion frieze and a pediment with modillions. Most

A burial vault (a contributing structure) is set into the hillside below and to the south of the meeting house. Employed for body storage, particularly in winter, the arch-shaped stone vault has large, plain double-iron doors. While its date of construction is unknown, the date certainly falls well within the period of significance.

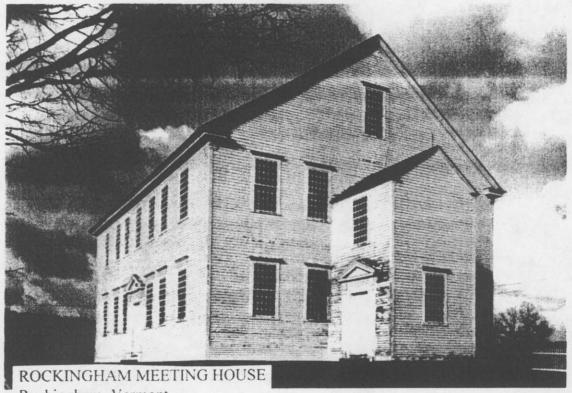
Rockingham, Vermont East facade, close-up Photo by C.B. Johnson, 10/99

The symmetry of the main facade extends to the identical end stair-towers or "porches" as they were described by contemporaries. The entries on each side are detailed in the same form and order as the formal entry, except they are slightly smaller, enclosing a single eight-panel door, and have only applied pilasters doubling the entablature en-ressault and no modillions on the pediment. Centered above each entry is one fifteen over twenty light sash abutting the eaves, which on the towers have a minimal entablature in contrast to the ornately molded entablature of the main mass. The towers each have one other fifteen over twenty window capped by the cornice found in the formal facade entablatures and centered on the first floor on their gable ends (east and west) and no windows on their north sides. The gable ends of the Meeting House have two twenty over twenty windows on each floor on each side of the towers and one above the tower gable lighting the attic beneath the main gable, all topped with the cornice which is also the standard window cap on the side and rear elevations.

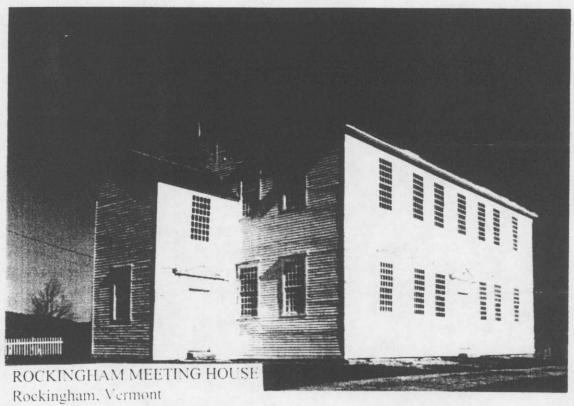
Rockingham, Vermont West and south facades Photo by C.B. Johnson, 10 99

If one imagines a center line defined by the vertical center opening of the formal double door, the complete facade left and right is rigidly bilaterally symmetrical. Windows on the first floor are aligned with those on the second (which abut the cornice) in a spacing between windows that starting from the second floor center window is approximately three feet, two feet, four feet, and seven feet to the simple fascia cornerboards. This arrangement subtly expresses on the facade the five-bay structure of the post-and-beam frame which leads to the pairing of the inner windows (two feet apart) within one structural bay.

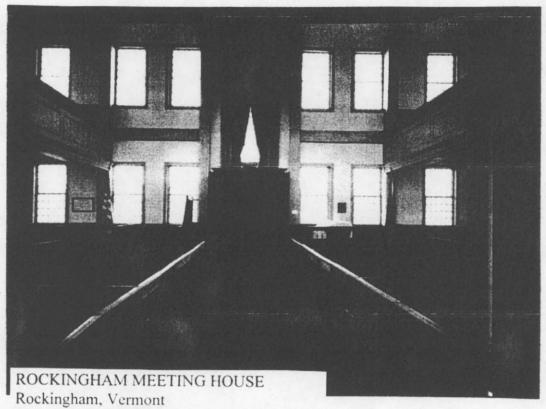
Looking north toward pulpit from formal entry Photo by C.B. Johnson, 10/99

Within the volume defined by this massive frame is set a first floor of box pews and a threesided gallery above, all focused on a raised pulpit and arched window in the center of the north wall. The first-floor plan consists of a five-foot wide central aisle from the formal entry to the raised pulpit. The central aisle bisects a rectangle formed by three-foot wide aisles that service boxes around the perimeter and connect to four-foot wide aisles leading through a doorway into both side towers. Around the perimeter there are twenty-four slightly raised box pews, six by six feet square, except in the corners where they are six by eight feet and along the north wall where they are five by six feet to create more room in the center for the raised pulpit and its stair. In the center of the rectangle are twelve, six by eight foot box pews, three reached on each side of the main aisle and three reached by each of the side aisles parallel to the main aisle, as well as three long benches in front of the pulpit on each side of the center aisle which run to the parallel side aisles. "These pews were the 'official' pews occupied by the tything-men and deacons in the early years of the existence of the church." Walls are white plaster and the finishwork is generally of aged white pine except the pews which have very worn grey paint on their aisle rails. The gallery front and posts and the trim of wall posts have fading grey-green paint, and the window surround around the pulpit window and the sounding board are painted an olive pastel.

The pulpit is seven feet wide centered at the end of the main aisle and its bold top rail entablature is nearly nine feet above the floor. It is accessed by a stair to its left (west) side, recessed one step from the aisle before ascending six steps to a platform and then turning two steps into the pulpit. Simple rails with square balusters and square, capped newel posts line both sides of the six steps and the west side of the platform. In front of and beneath the pulpit, is a shallow box pew, ornamented like the others, with a seat projecting from the base of the pulpit and its door next to the stair. Above the seat the face of the pulpit is divided into roughly three bays, two by three by two feet wide, with the upper portion of the wider center

Behind and above the pulpit, the arched window and sounding board exhibit the most elaborate original detailing, appropriate to the focal point of the interior design. The window is centered within a flat rectilinear surround capped by a full entablature with denticulated cornice and is flanked by twin applied Doric column pilasters (most similar to those on the exterior stair tower door surrounds) which also carry through as a decorative cap en-ressault as a projection in the entablature. An applied console keystone above the arch supports a similar decorative projection of the entablature. Covering the top of the entablature cornice and projecting out almost at a right angle to cover the speakers bay of the pulpit is the sounding board, which projects from the wall in a rectilinear fashion before its front half becomes polygonal (half a hexagon), no doubt echoing the design of the original pulpit once below. It is trimmed with another full entablature, with en-ressault capital projections at its corners and centered between corners, which is surmounted by a set-back wide fascia band with cornice topped by a low ogee cap. The underside, directly above the pulpit, has a large button pendant on a raised, flat circle with seven arms radiating out to the sounding board soffit.
