RE: Root School, 987 Union Village Road, Norwich, VT
Formal Listing in the National Register of Historic Places

NATIONAL REGISTER OF HISTORIC PLACES
REGISTRATION FORM

historic name: Root School

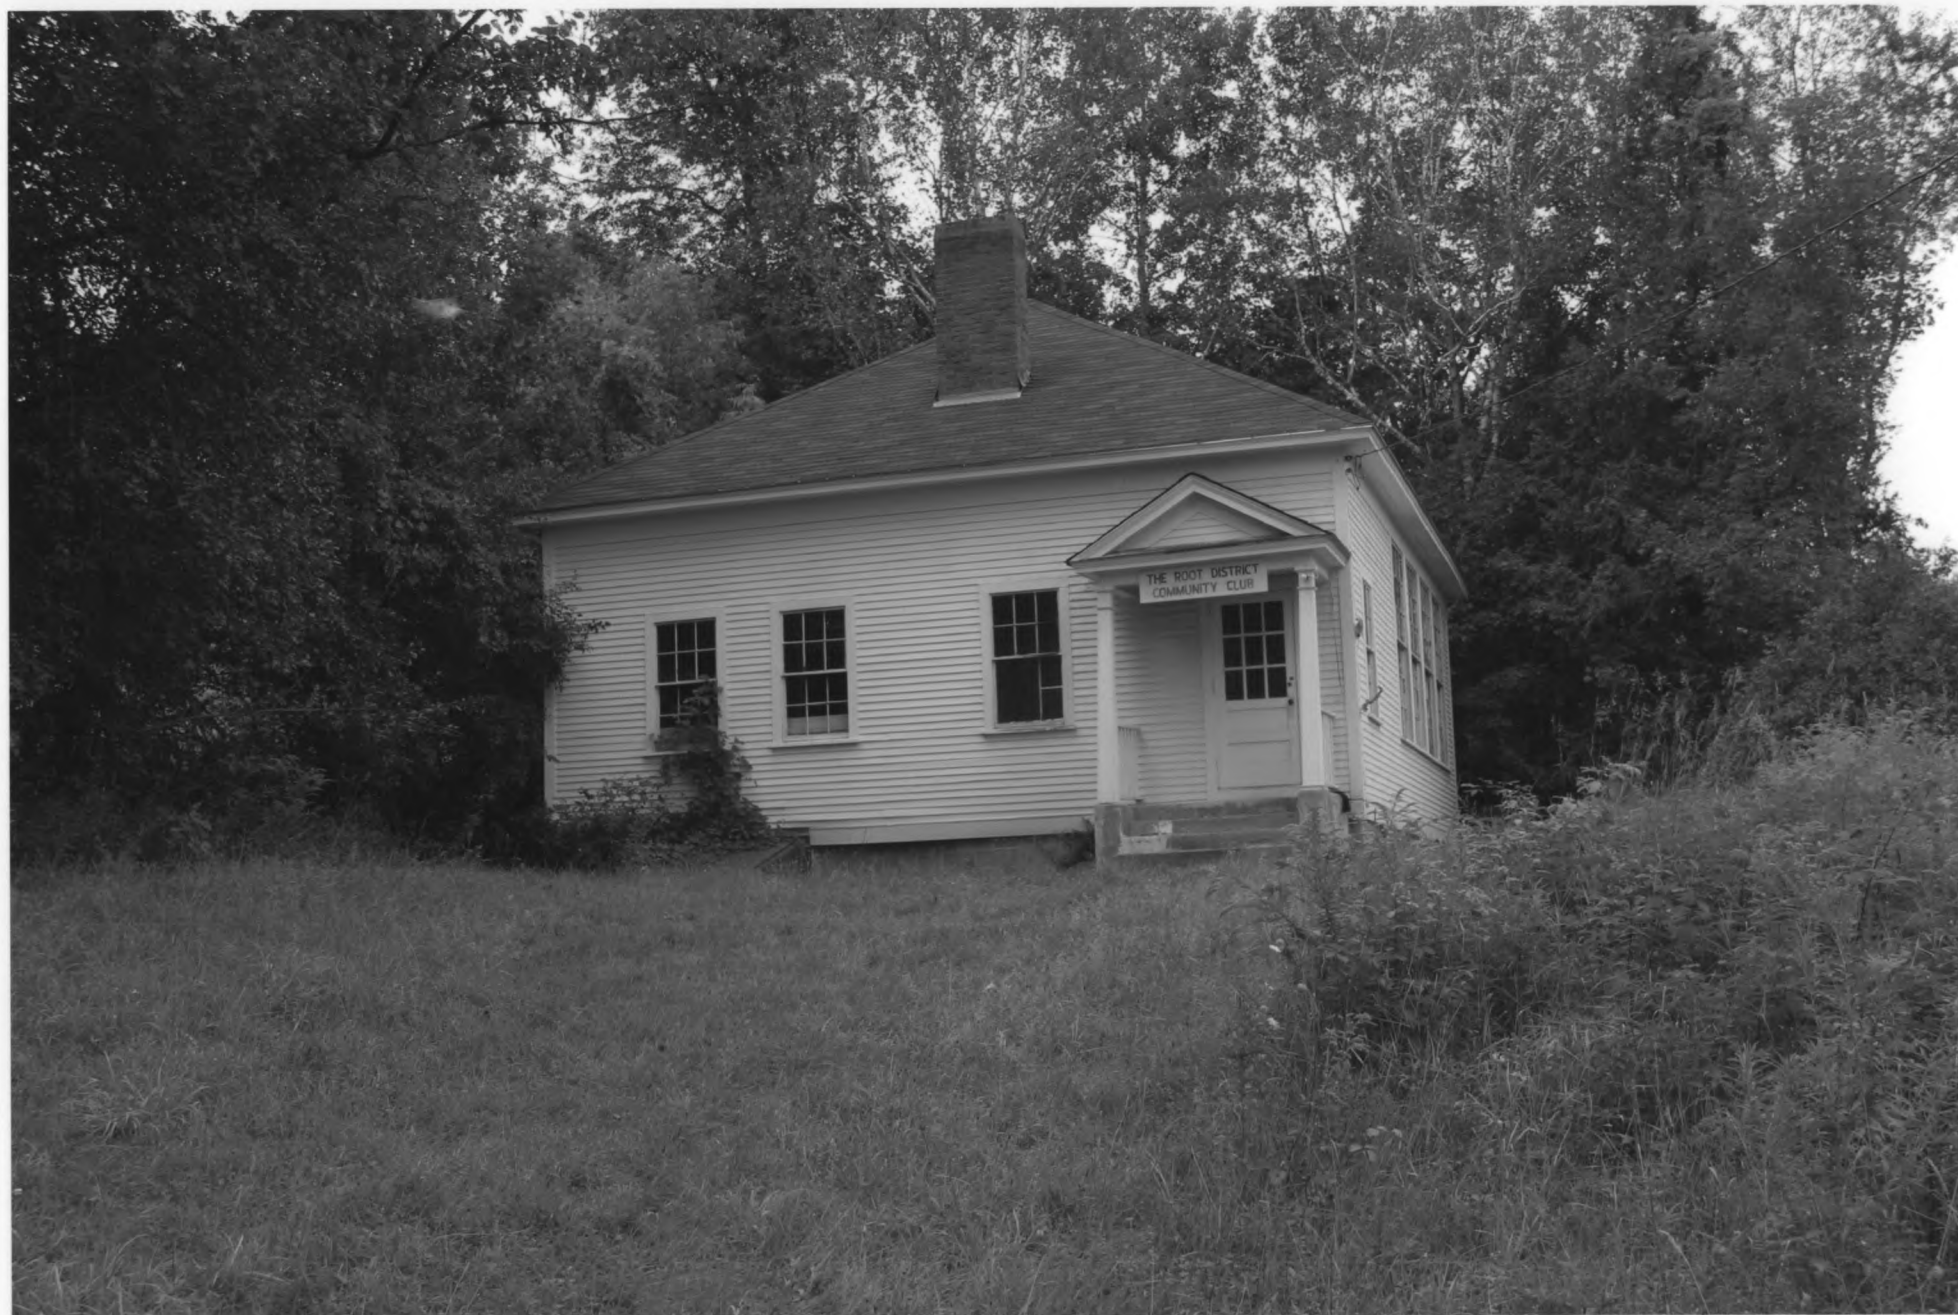
Photograph #7 of 15

Root School front facade (south) and east elevation, view looking north

The Root School is 32' by 38' with a hipped, pyramidal asphalt shingle roof. The clapboarded building has plain wood trim and frieze boards and sits on a high 1975 concrete and concrete block foundation that has basement windows on the south and east sides. It is a very simple building which is stylistically distinguished by its massing and a classically detailed, though simple, 5' by 8' entry porch. The main entry is on the east side bay of the south façade up a half flight of concrete steps. The steps have cast concrete side walls that support a gable-roofed porch embellished by a full pediment with molded cornice and a simple entablature resting on battered square Tuscan columns. The columns, made of nailed together boards, have a simple astragal band near the top and a plain abacus block at the top. There is a simple wood railing at either side of the concrete porch platform with square spindles. The porch ceiling is a narrow, varnished bead board. The front (south) façade has three six-over-six light, double-hung wood sash windows and a nine-light glazed and paneled wood door. There is a brick chimney on the front roof slope and a bulkhead cellar entrance at the western side of the front façade with metal doors added sometime after the 1980s.

The east elevation faces the road and has the characteristic bank of large schoolhouse windows. There are four, twelve-over-twelve light, double-hung wood sash windows in a bank covering the northern two thirds of this elevation and starting just under the eaves. A smaller, six-over-six light window, similar to those on the front façade, is located near the south end of the elevation and its sill aligns with the sills of the four larger windows. The foundation has five irregularly placed six-light fixed wood sash windows. Three are clustered near the northern side and are under, but not vertically aligned with, the bank of large windows above. The concrete foundation wall is badly cracked and is also buckling.

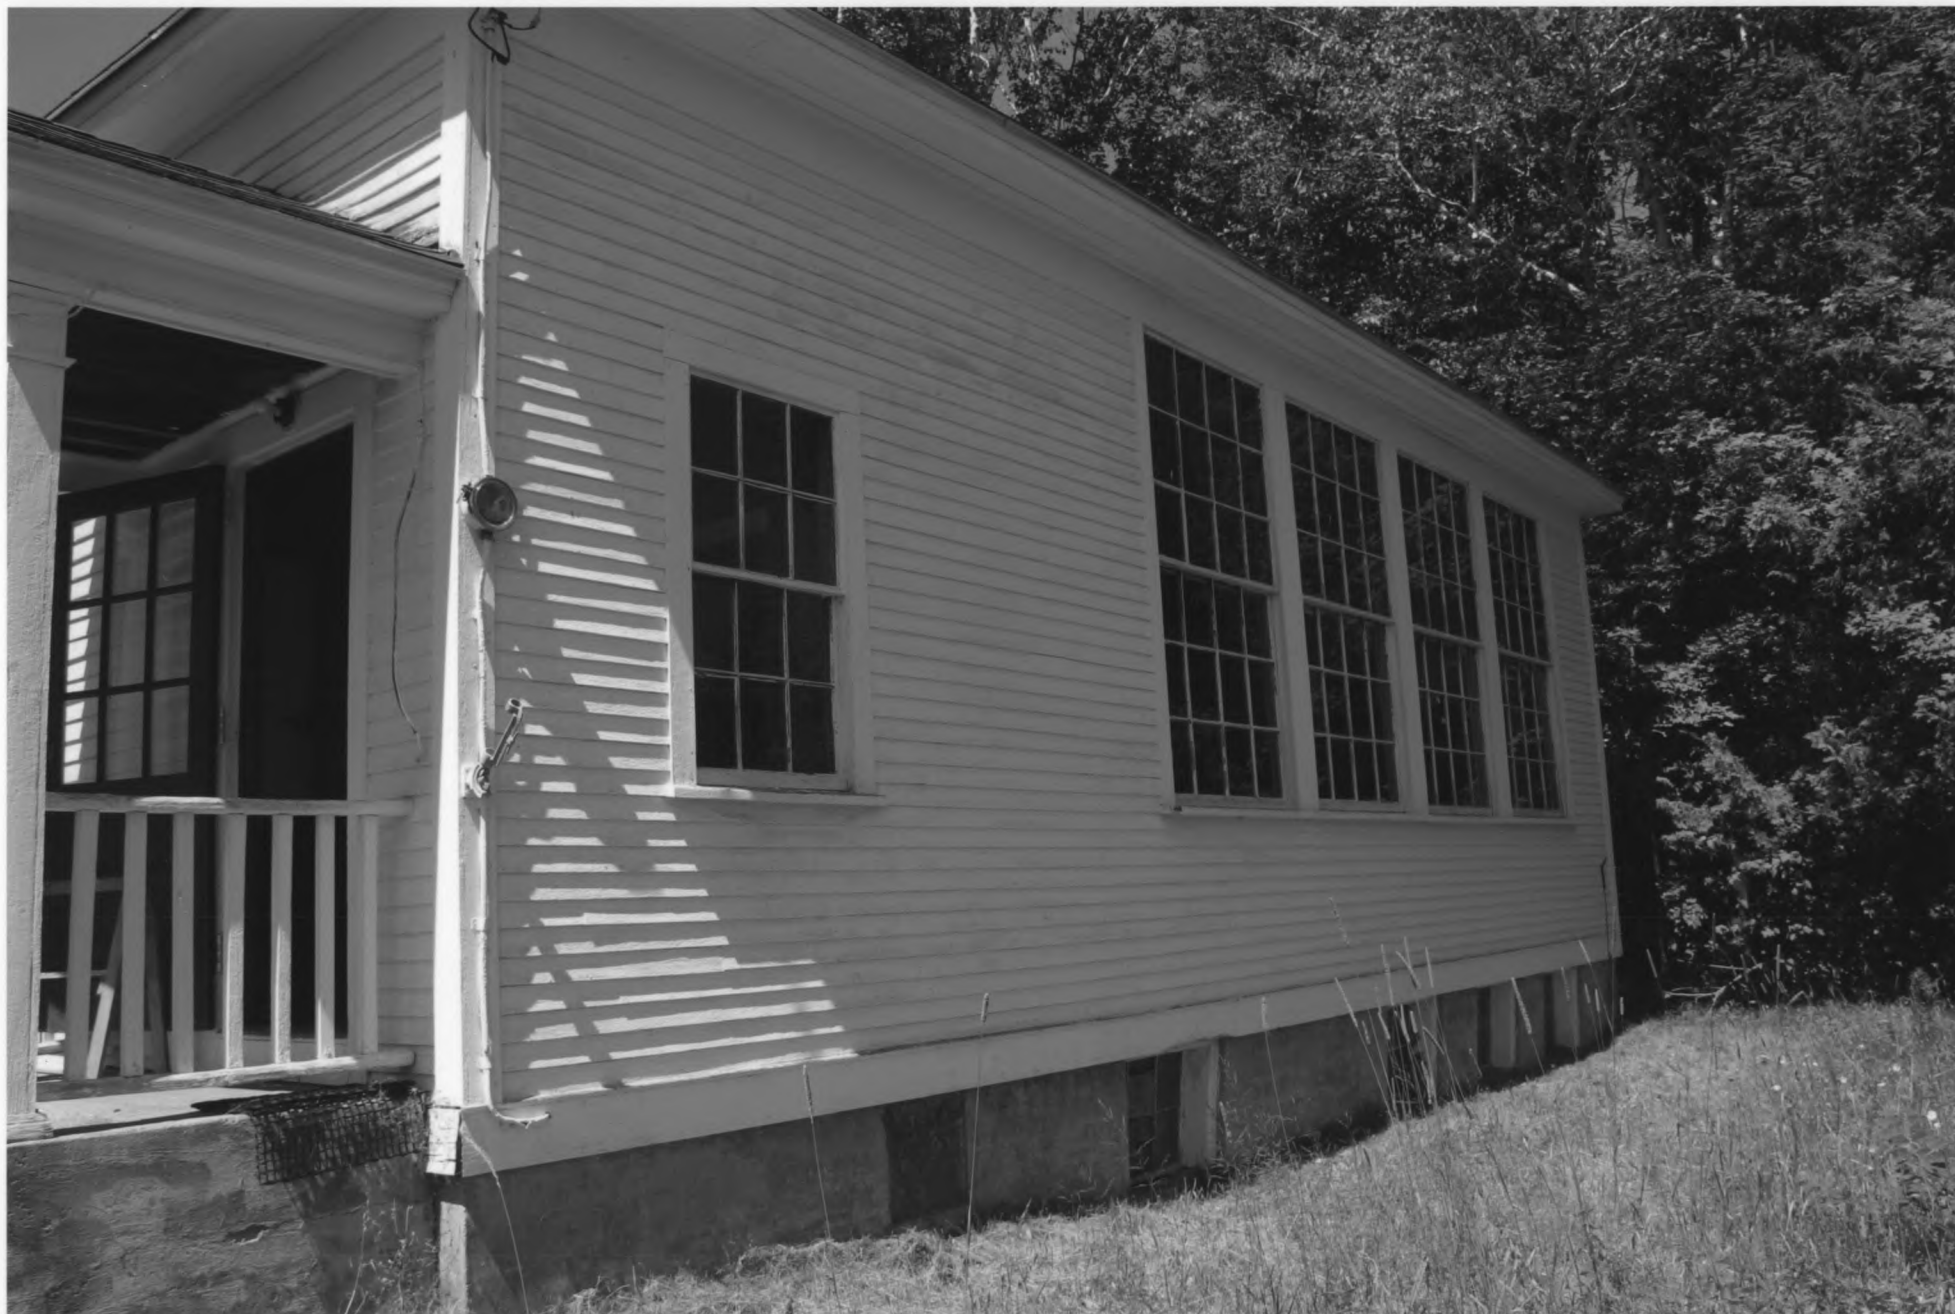
Root School, Norwich, Windsor Co., Vermont
Photograph #8 of 15
Root School east elevation, view looking northwest

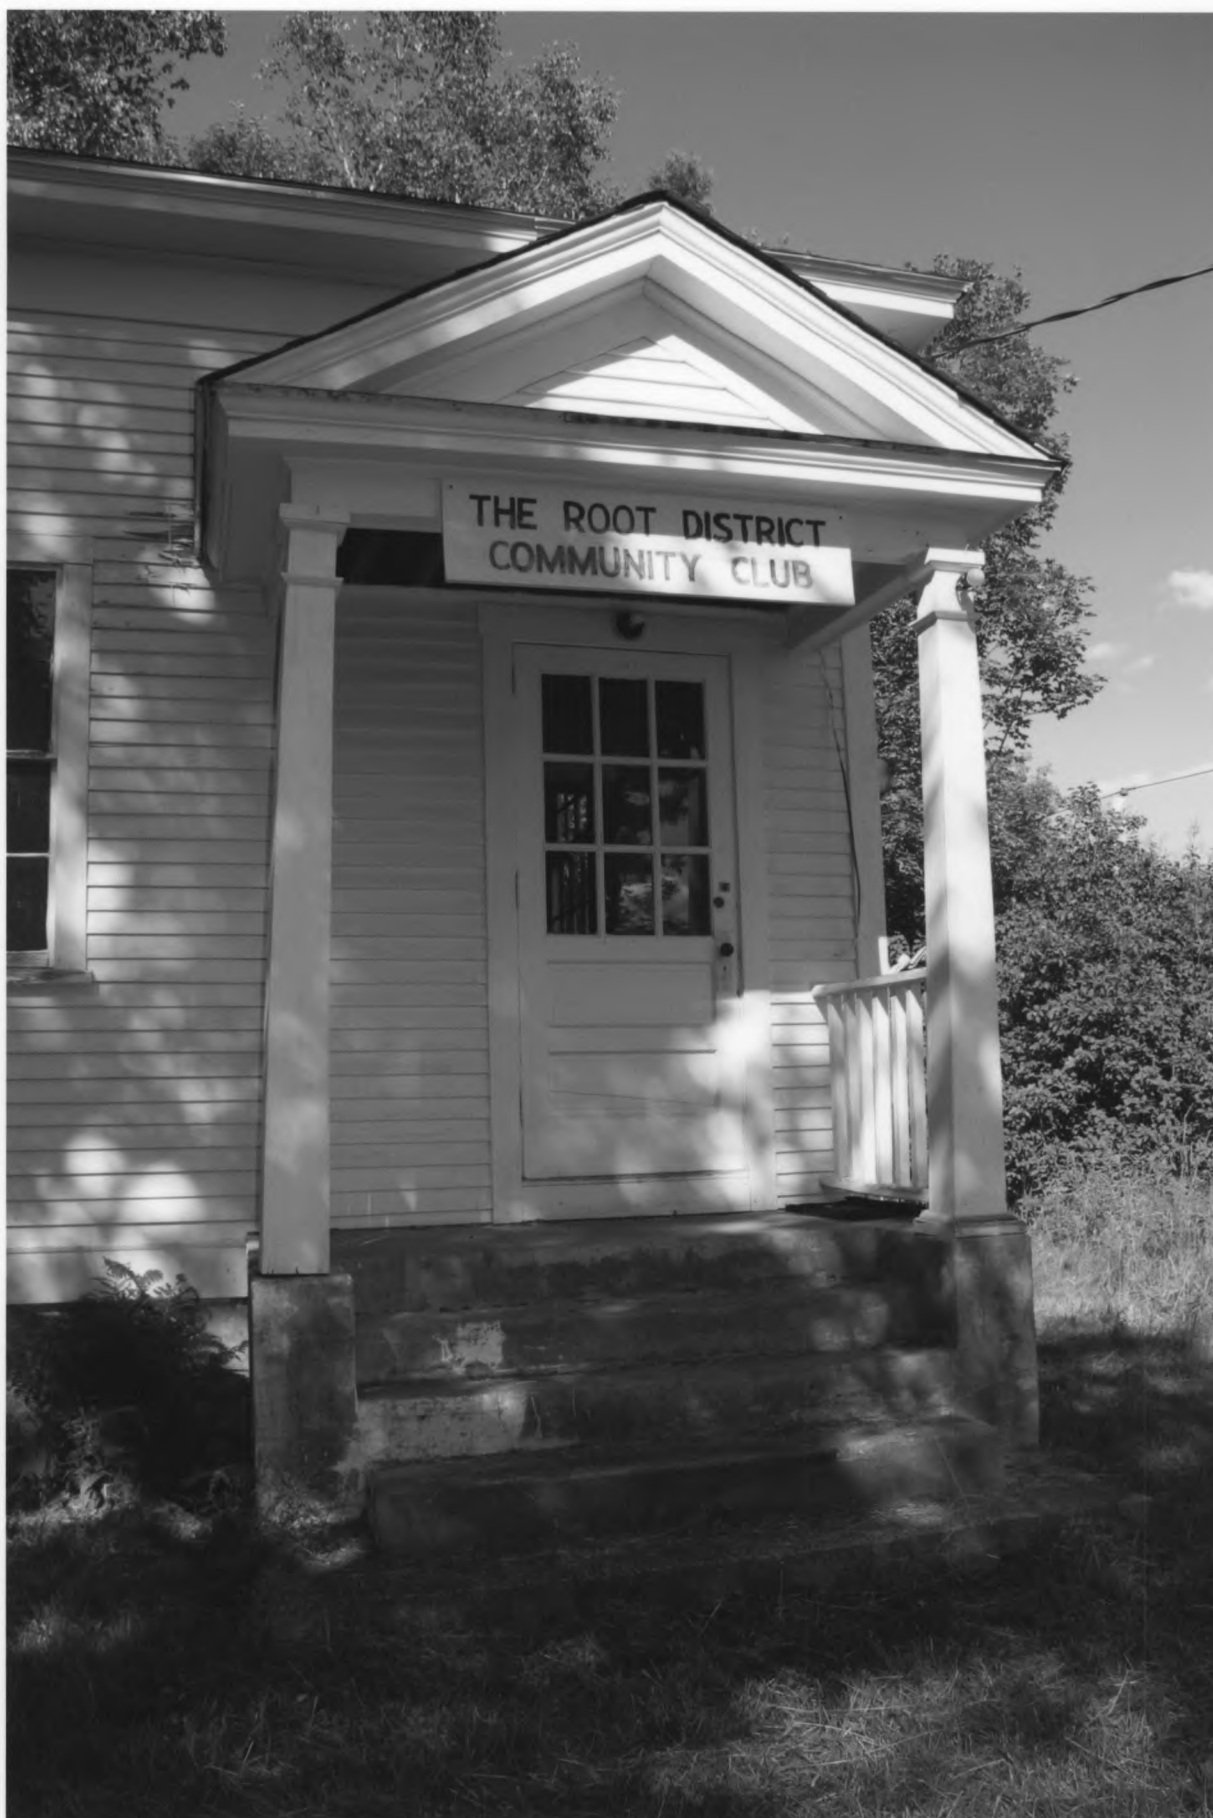
Root School, Norwich, Windsor Co., Vermont
Photograph #9 of 15
Detail front (south) facade, view looking north

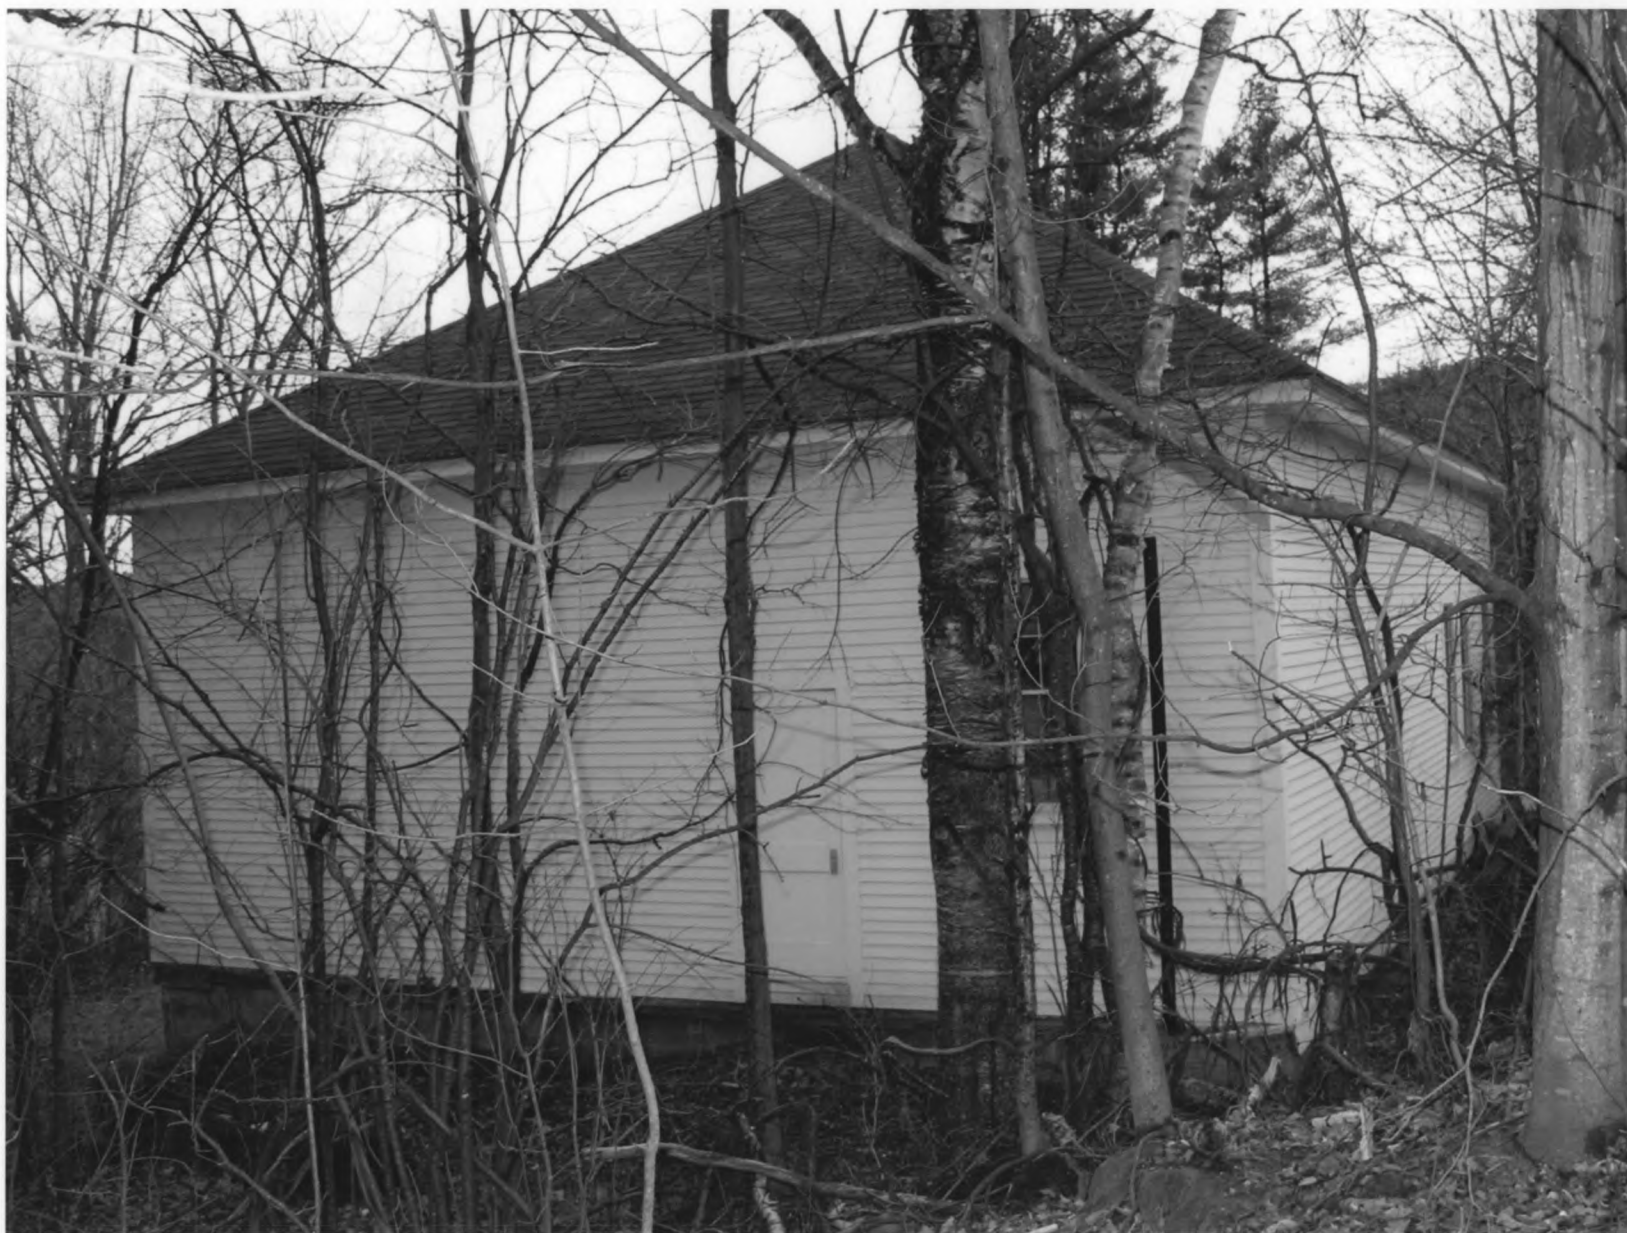
Photograph #10 of 15

Root School rear (north) and west elevations, view looking southeast

The north (rear) elevation has one six-over-six light double-hung sash window near the western end and a non-centered door that is well above grade as on the front façade but currently has no stair. The door is a wood, two-panel type that is similar to many interior doors of this era and currently has no door knob. The rear foundation wall is concrete block with no window openings

but a small screened vent near the western corner. It is also exhibiting cracking. A bathroom vent pipe comes out of the wall near this vent and extends up about ten feet.

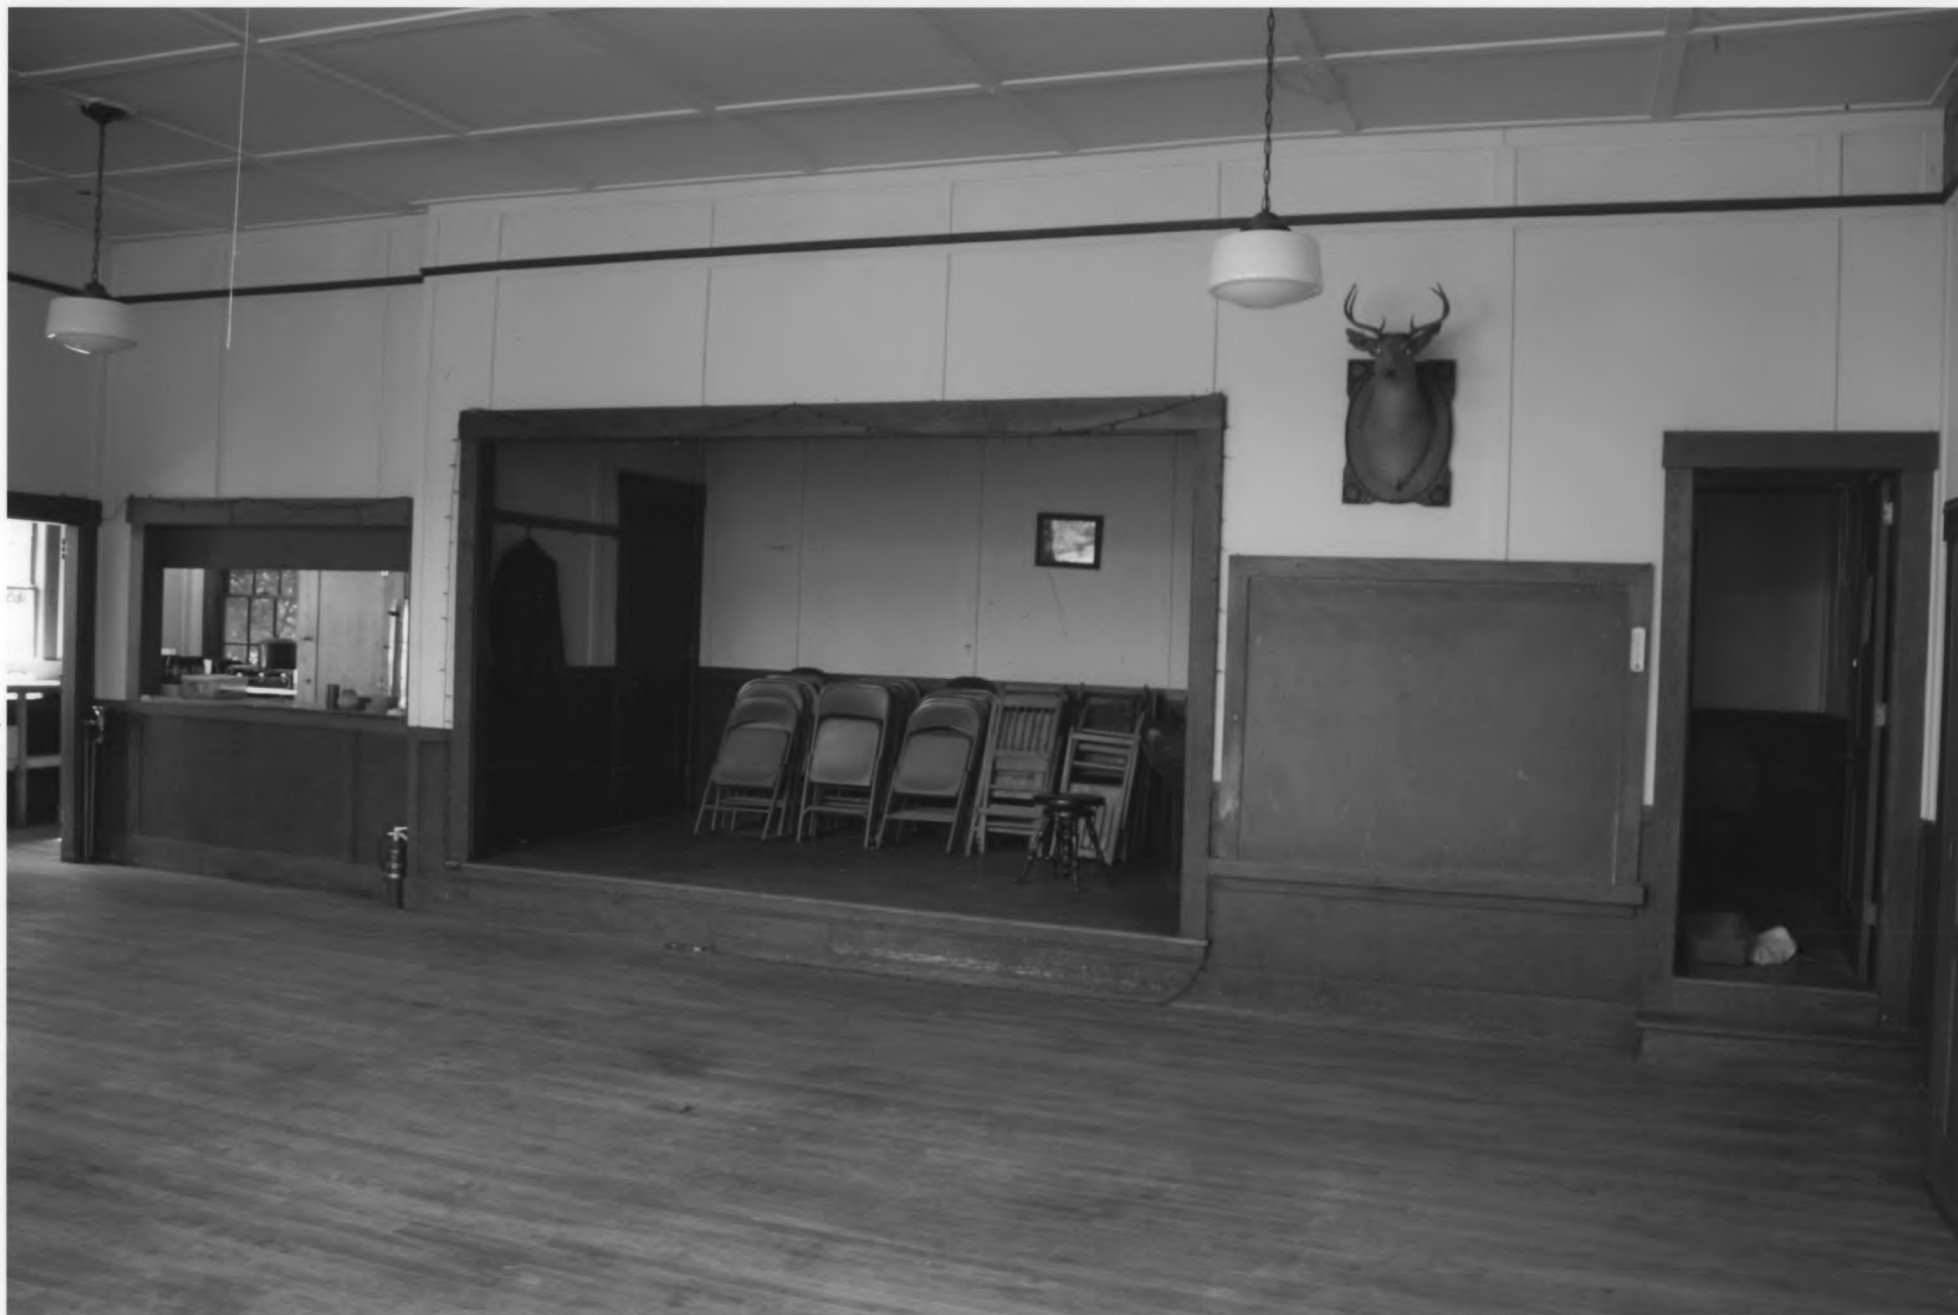
Photograph #12 of 15

Classroom with stage, kitchen/cloakroom, and toilet room, view looking southwest

The Root School is a one-room school building with a recessed stage alcove on one side flanked by a small kitchen area at the front that was most likely the original cloak room and two original toilet rooms at the rear. There is a full basement and the attic space is not accessible. It is remarkably intact historically and architecturally, although the foundation was replaced in 1975 and is in very poor and unstable condition today. There are many surviving original features throughout the building including the raised 8" stage platform and square, trimmed arch, window sash, door and window casings, slate black boards, two-panel plywood doors, low, framed, plywood wainscoting, strapped press board walls and ceilings, wood flooring, iron ventilation grates, schoolhouse pendant lights, and the two original enameled metal train station style toilet fixtures with pill box tanks.

The main classroom is about 20' by 30' and has the same trim, wall and ceiling details as the vestibule. The large bank of windows is on the east wall opposite the stage alcove. There is about 2' high pine plywood wainscoting below the windows. The front (south) wall of the classroom has a slate blackboard framed in stained pine trim and pine plywood wainscoting below. In the western corner of the room there is a door to the kitchen, which is a narrow space wrapping around the southwest corner of the building and may have been the cloakroom originally. The long western wall of the room has a pass-through window to the kitchen above three foot pine plywood wainscoting, the roughly 12' wide square arched stage alcove, a framed blackboard, and

The kitchen area is about 5' wide and has simple counters built across the front two windows and wrapping around the corner in front of a west façade window. There is a wash basin but no running water or plumbing, and two counter-top gas burner units. There is a large set of pine plywood cupboards along the west wall and in front of the other two west façade windows. There is a door, up one step, leading to the stage.

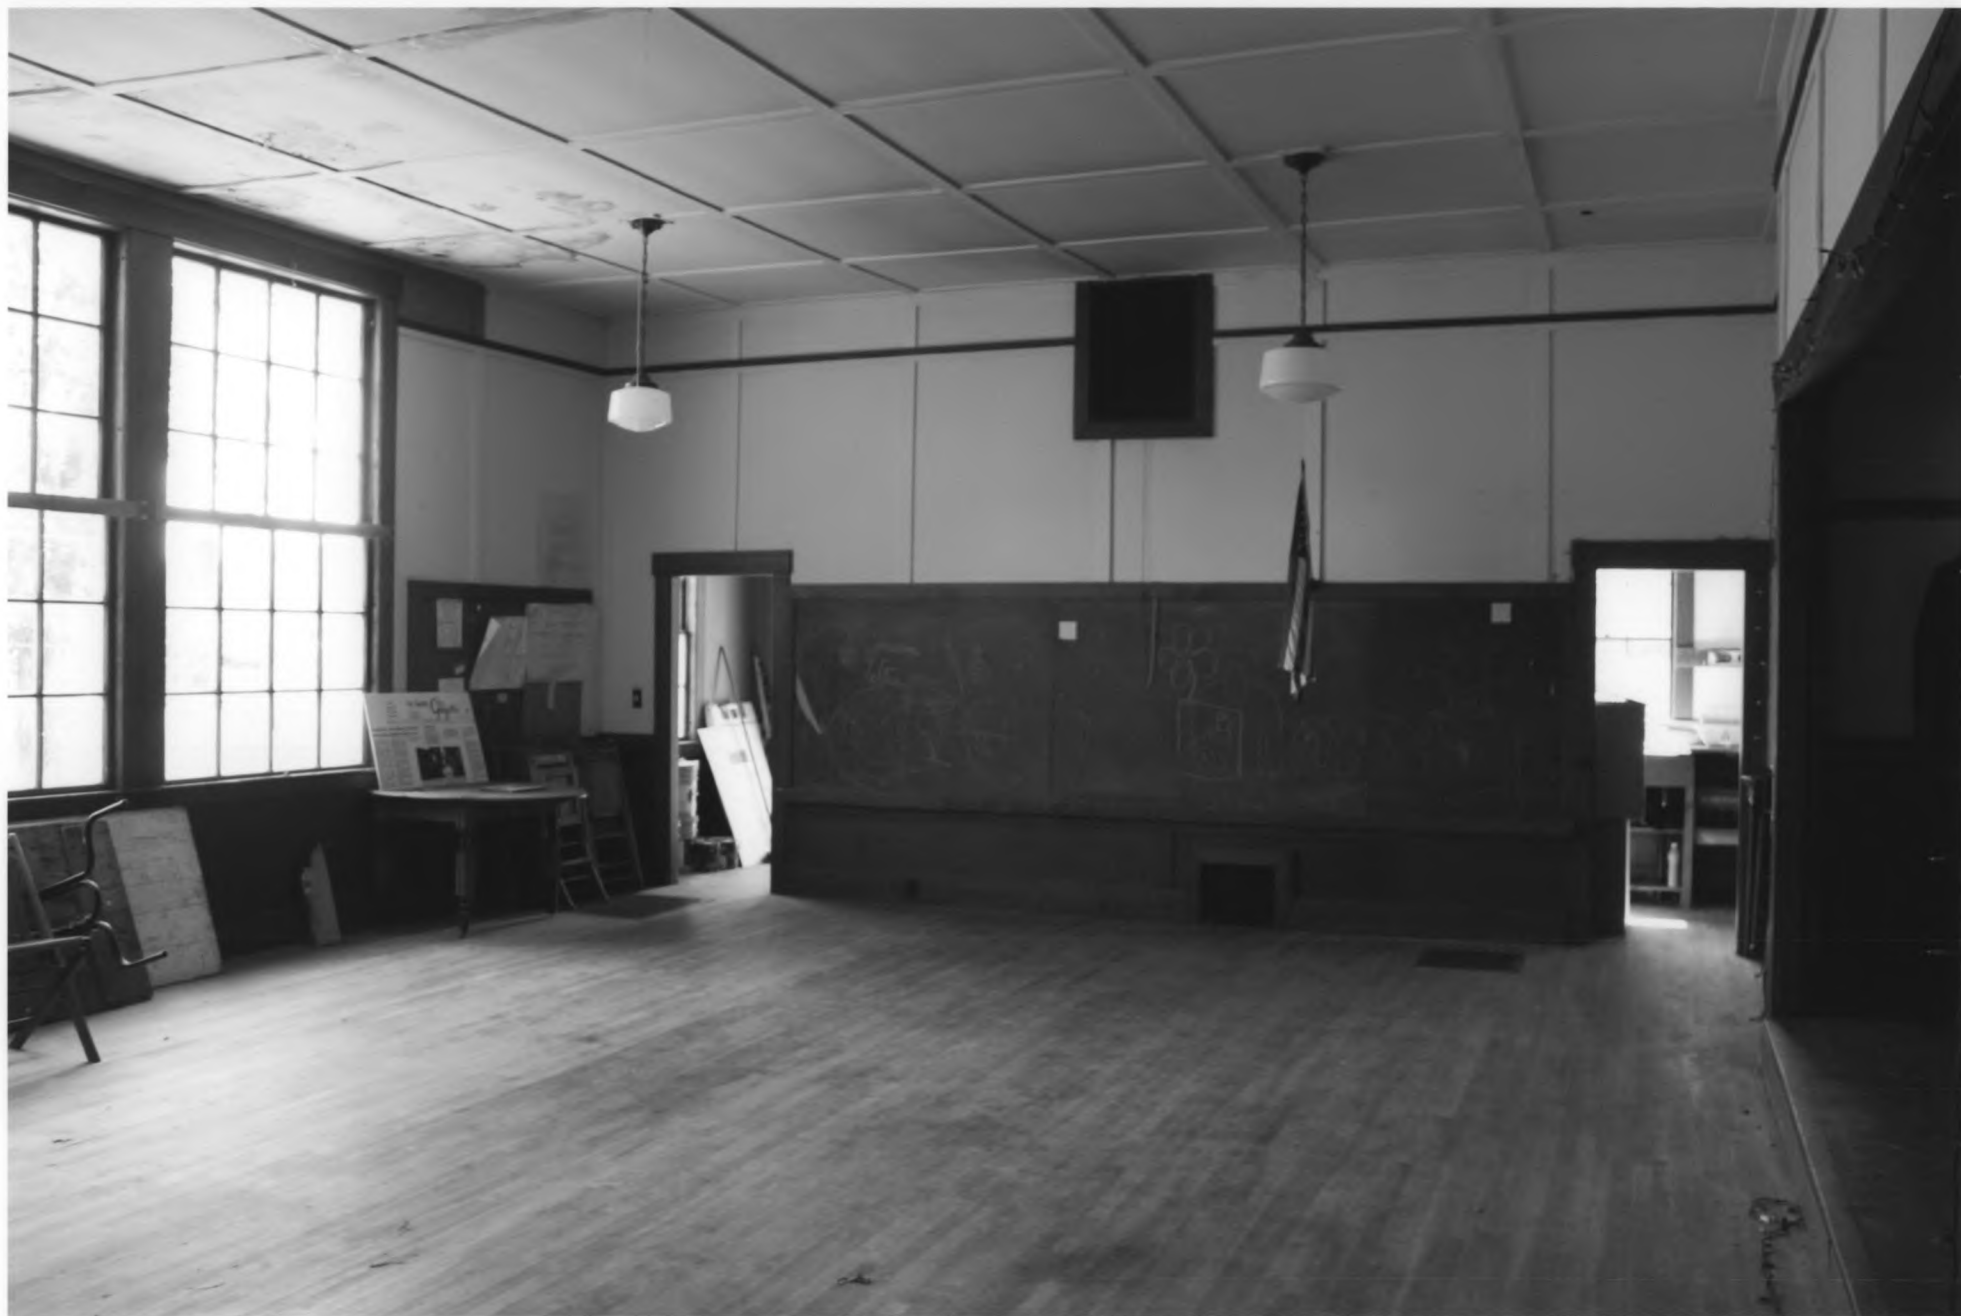
Root School, Norwich, Windsor Co., Vermont
Photograph #13 of 15
Classroom, view looking southeast

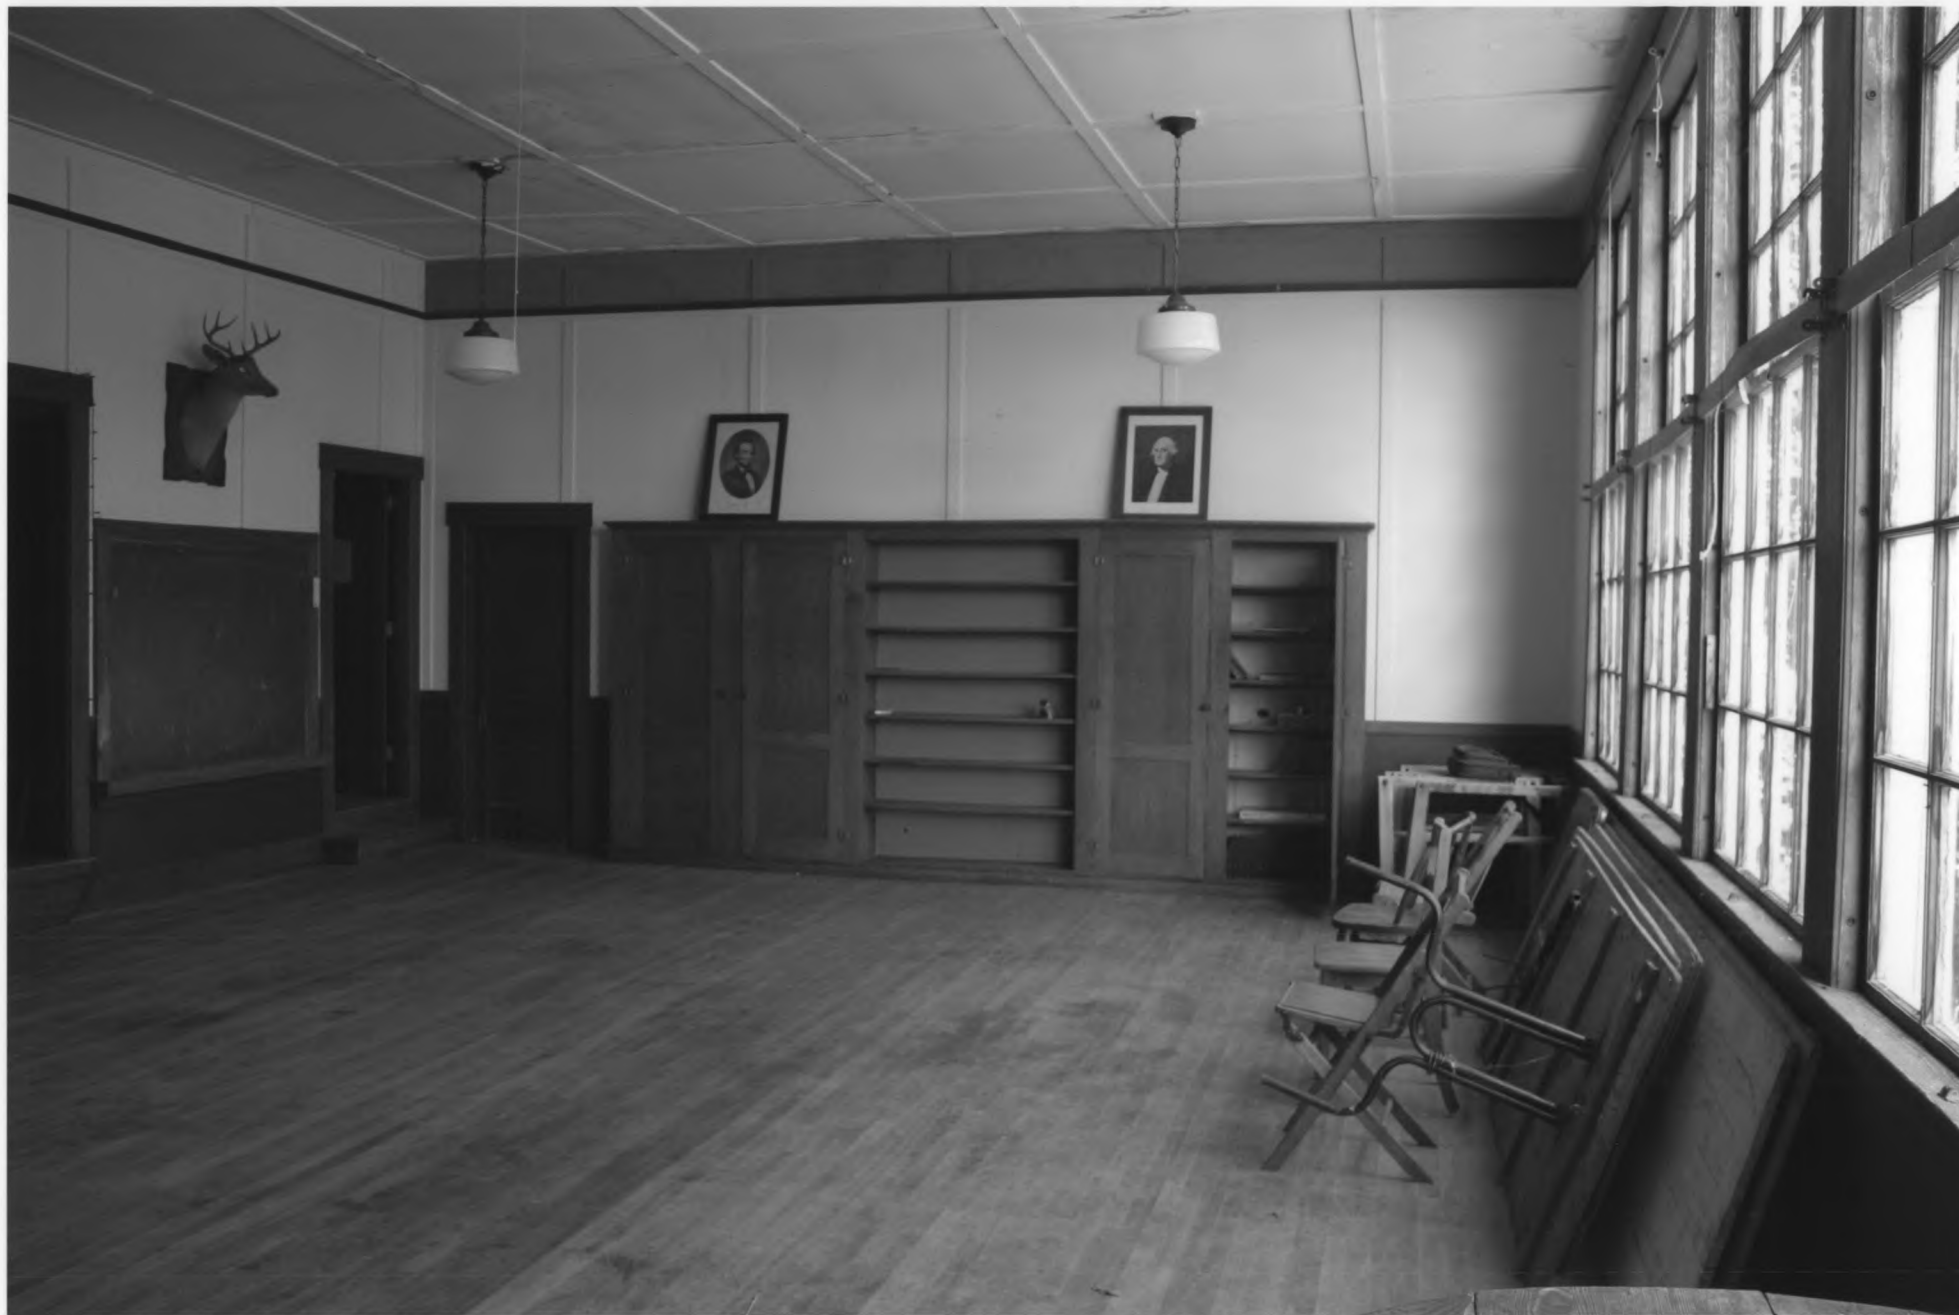
Root School, Norwich, Windsor Co., Vermont
Photograph #14 of 15
Classroom, view looking north
